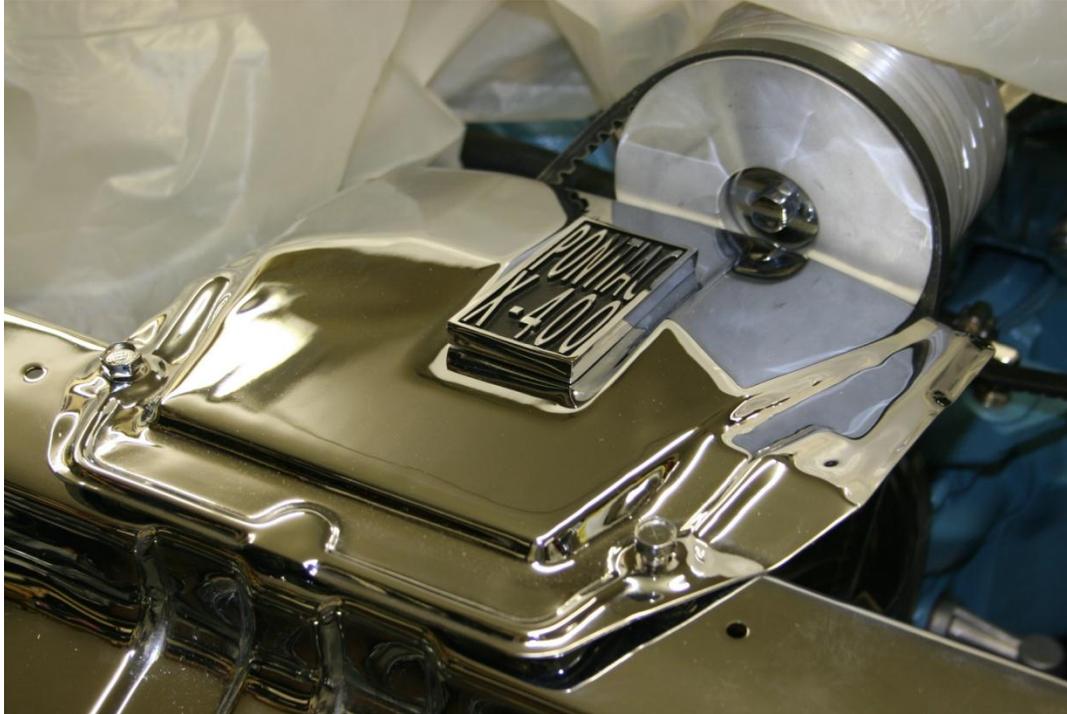
When I installed the top radiator support I found a problem. The support hit the blower pulley, After studying the factory photos I noticed they had cut it down to fit and clear the pulley So I cut it off and had it rechromed.

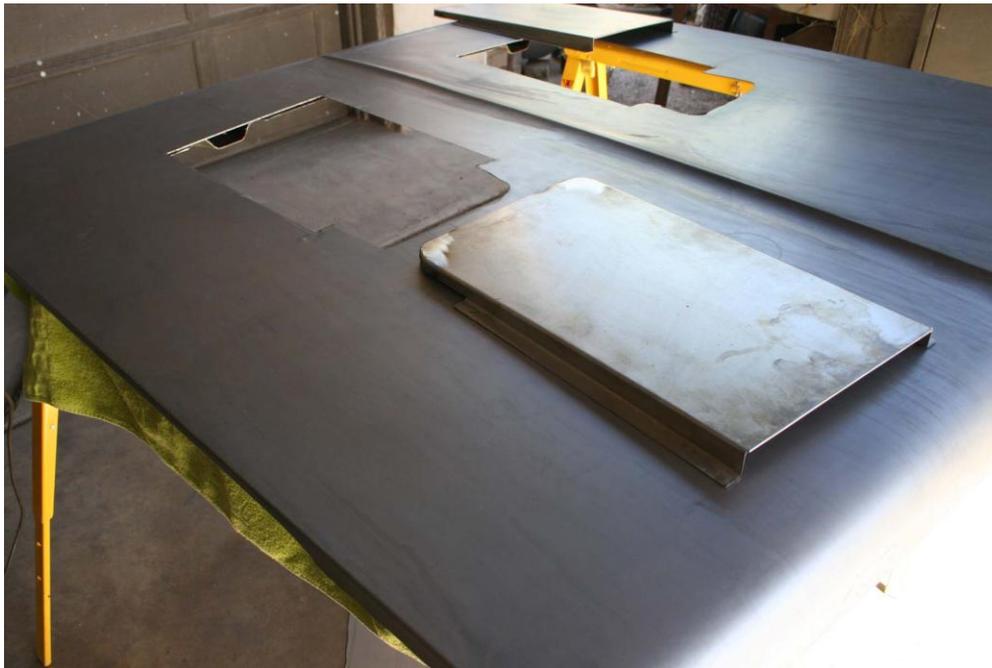
Next I laid out the location of the scoop and what need to be cut out. The cut was done using a plasma cutter with no problem. I planned on welding in the scoops. Try as I could I could not keep the unsupported hood from warping.

Holes cut and scoops ready for installation

So I had to make new scoops and use a new hood and keep the use of any welding or heat to a minimum. I stripped the hood by hand, cut the hole. I spot welded a metal plate that would hold the grill recessed below the hoods surface.

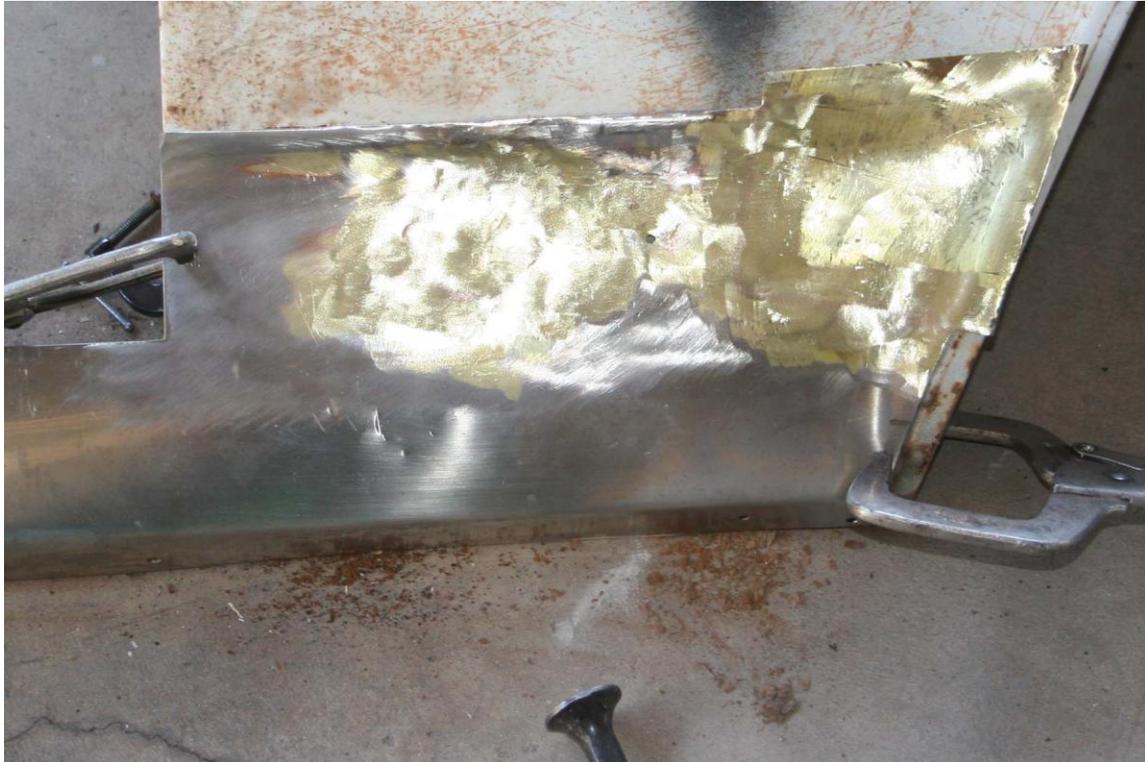
There was a problem plating the rocker molding. Something that was done in the past to these contaminated the metal. The plating would pop off and no repairs would work. I decided to cut off the bad areas and weld in new metal. These were hand made in brass. After removing the bad parts I used a similar brass plate, cut it to fit and we used a TIG welder and attached the new part to the rocker.

These were reformed to fit the fender, ground off and finished. The chrome was done and fixed the problems.

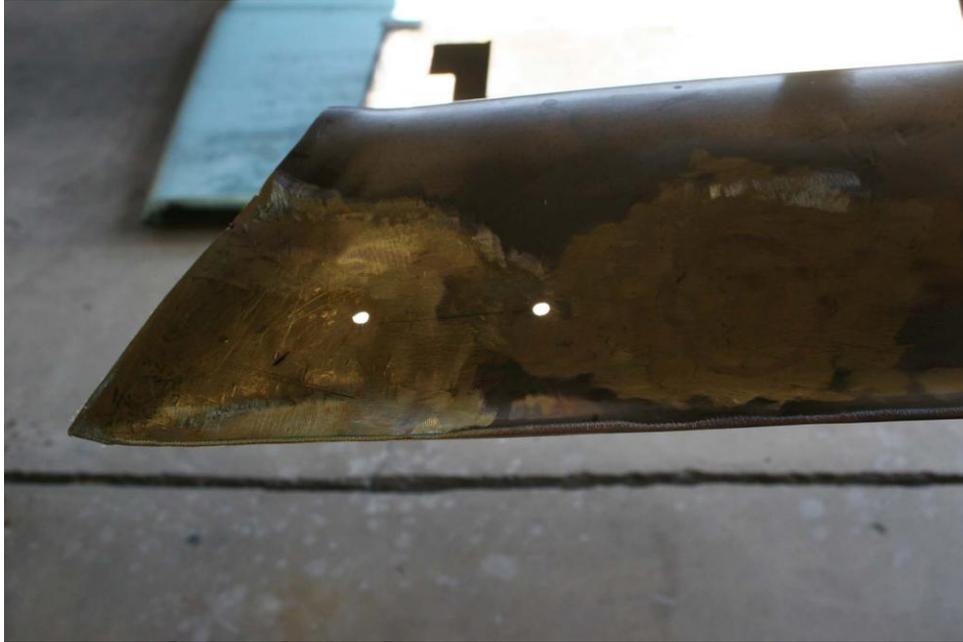
After repairs

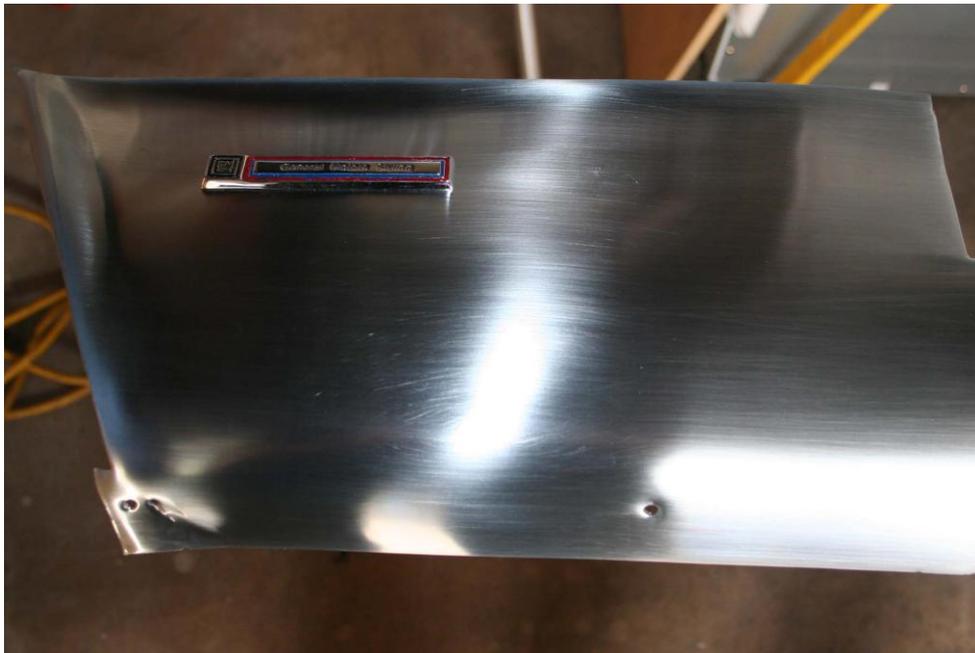
Left side finished repairs and plating

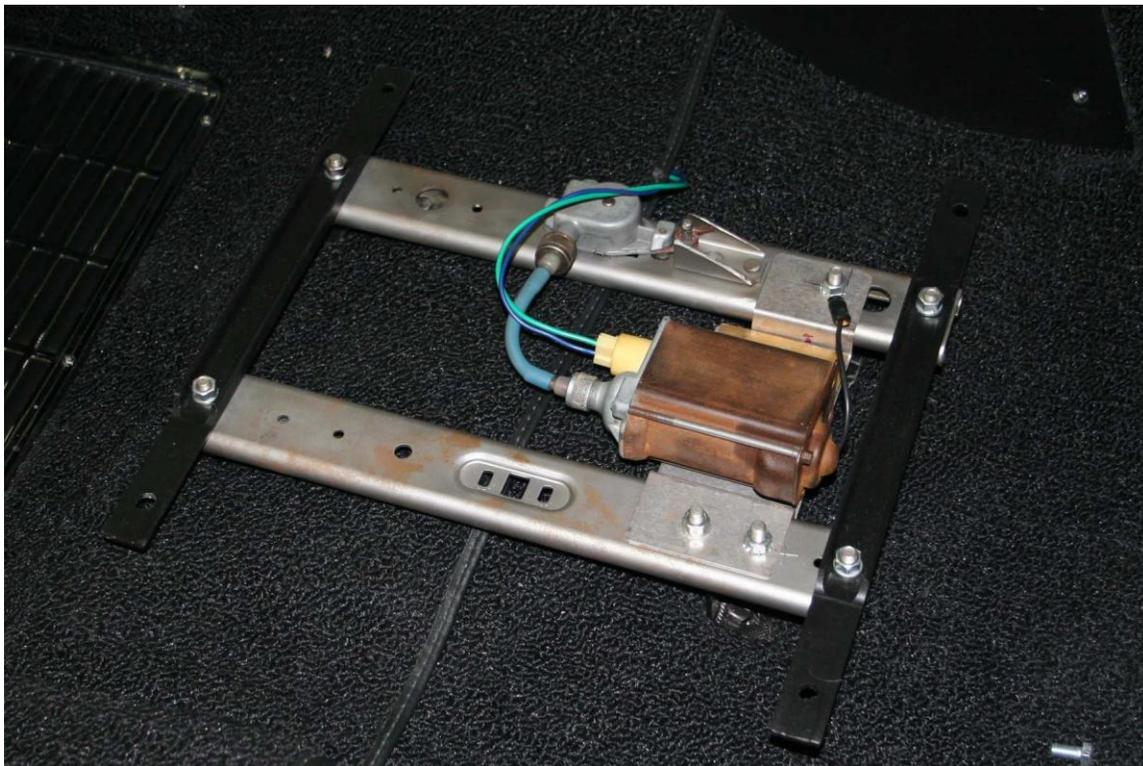
The test seat was made so we would see how it fit and if we needed to do any changes. We installed it on the 4 way mount and could see that we had a problem with the height and clearance with the 4 speed shifter lever. The seat was worked on and the height reduced as much as possible. We installed the seat again and it was still too high. This presented a problem that only had one solution. I could not use the 4 way seat mounts I made, it was too high. So I made a new mount that only went back and forth. This was as close to the floor as possible and solved the problem. However this took nearly 5 days to make the new mounts and I had to scrap the ones I did earlier.
