Jan 3:

I had to make a mounting plate for the choke cable, which goes under the dash. Worked on the wires to route them to the gauges, it had been a challenge to determine where everything goes. Cleaned and installed the wiper switch and cigar lighter in the dash. Nearly all the items are in the dash except the radio. It still needs to be repaired as well as the reverb unit. I also took all the console pieces to the powder coating facility for a wrinkle black paint. I have been unable to find any paint that still works for the wrinkle black and the powder coating works the best and produces a uniform coating.

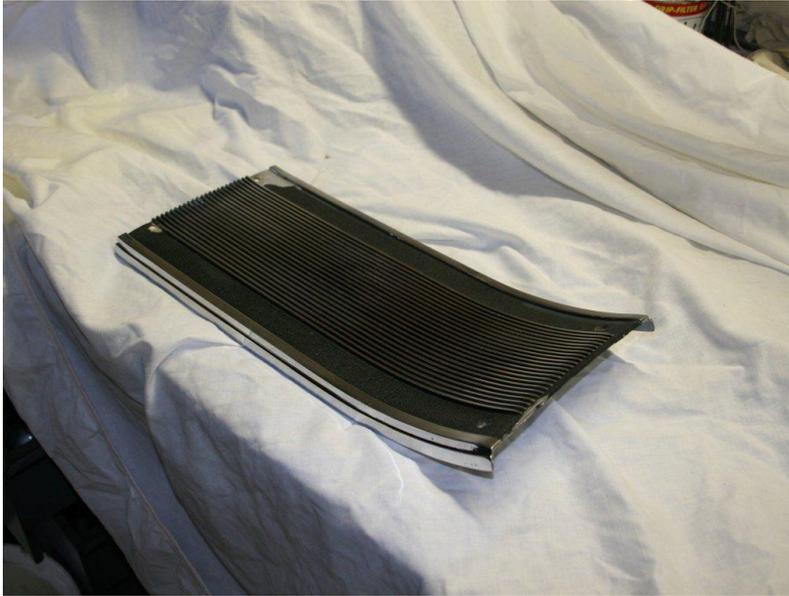
Front plate before plating and painting

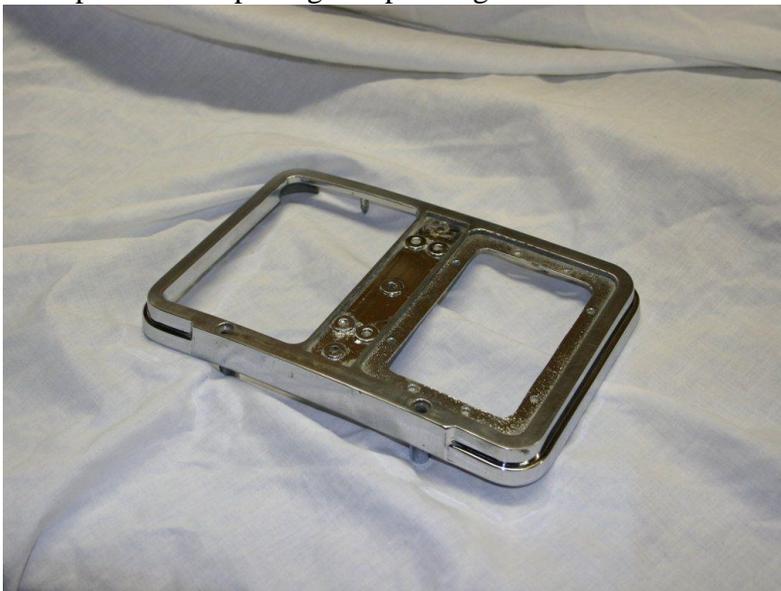
Shifter plate with hole for exhaust cutout lever

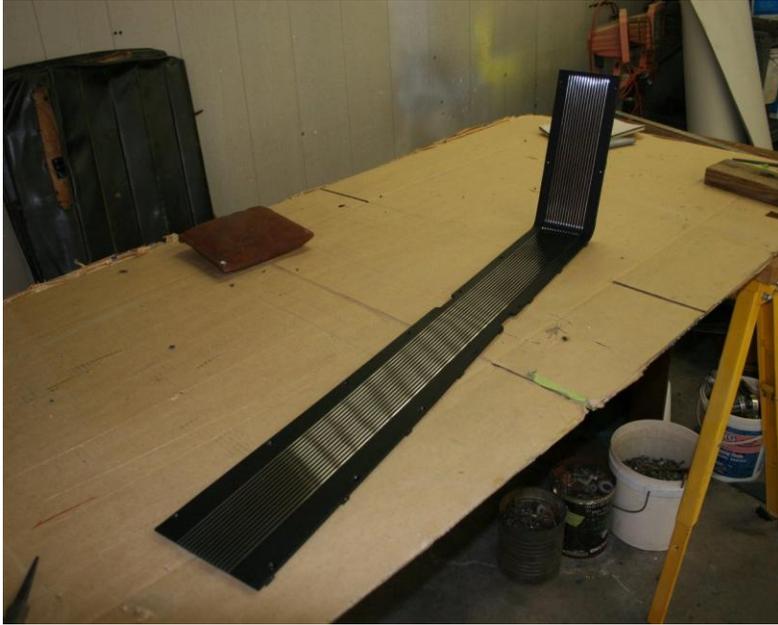
Rear console plate. Solid brass plate machined for console

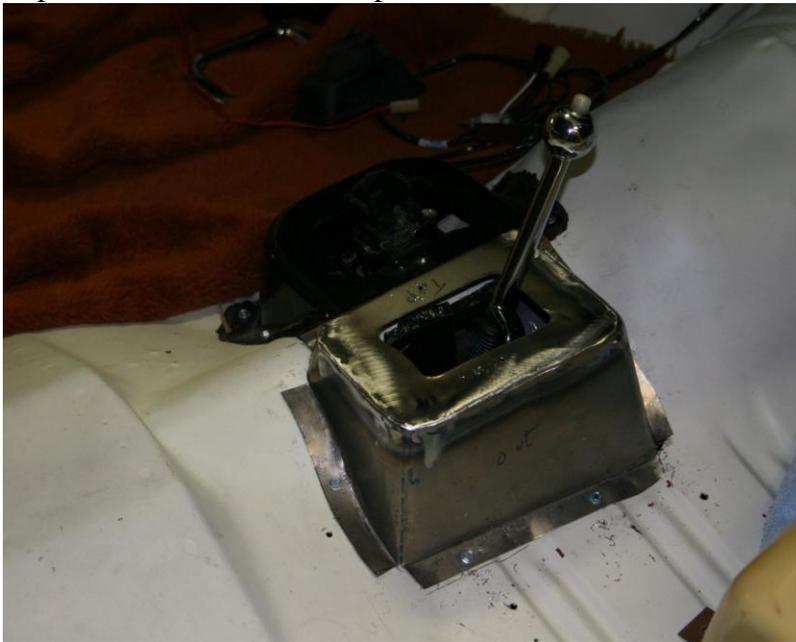
Exhaust cutout lever housing.

I continued worked on the wiring, which is a challenge to figure out. Designed and made a cover box for the exhaust cutout lever on the floor. With this done I can begin to fit the carpet and attach the console parts. This work took most of the days to complete.

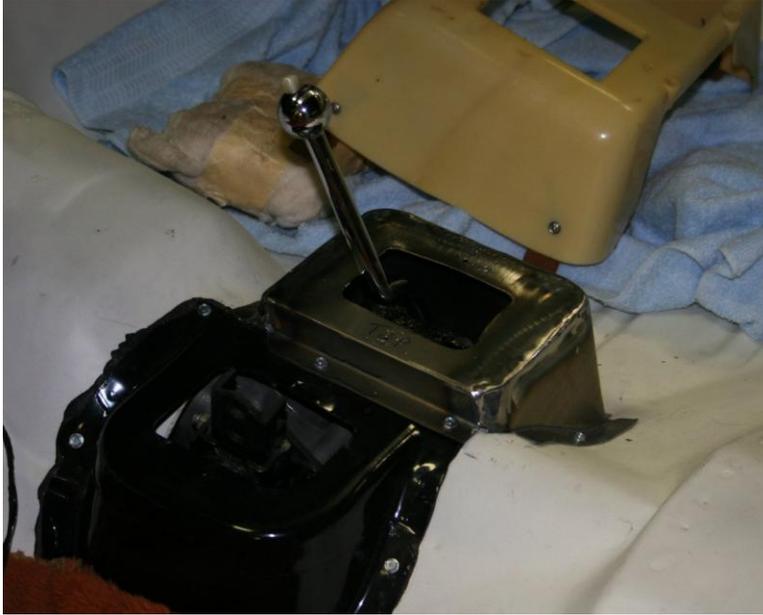
Shifter housing on the bottom and cutout on the top

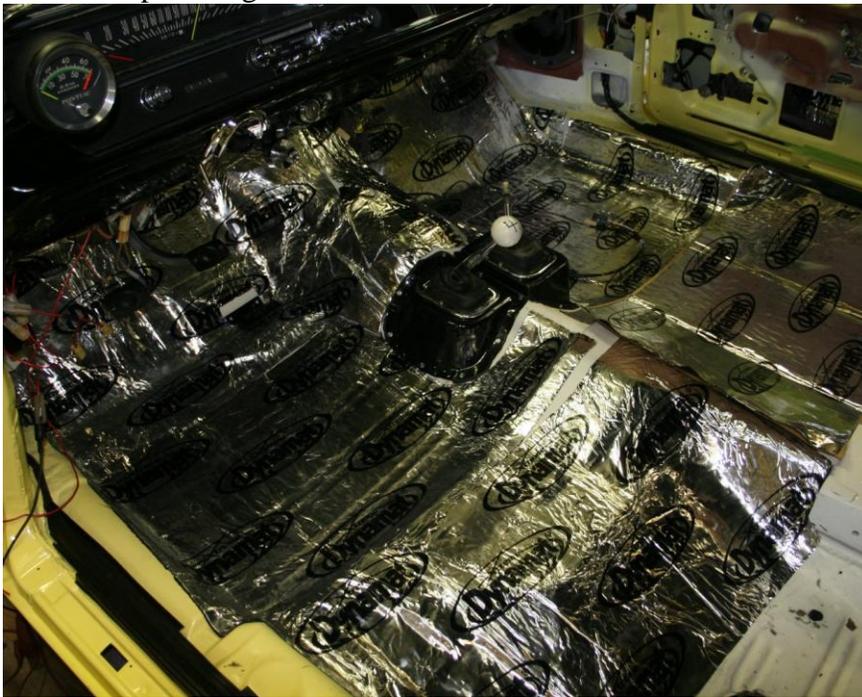
Sound deadener installed

Since the tar material is no longer available for the floor, I used Dynamat as a sound deadener. I installed this over nearly all the interior floor. I then cut and fitted heat shield in the wells for both the front and back. I started to fit the carpet in the rear and front. It will take some effort to fit this carpet. The original car had a combination of molded carpet and glued and fitted.

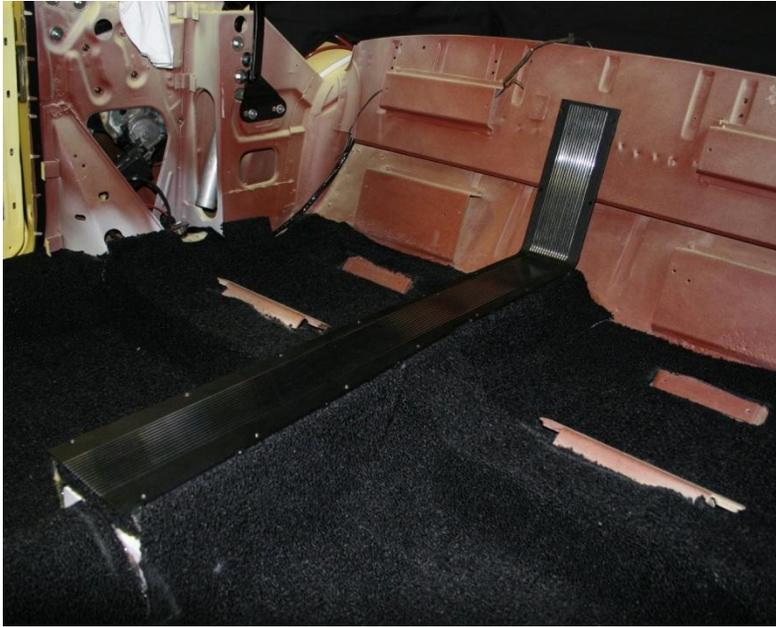
Rear console fitting and carpet installation

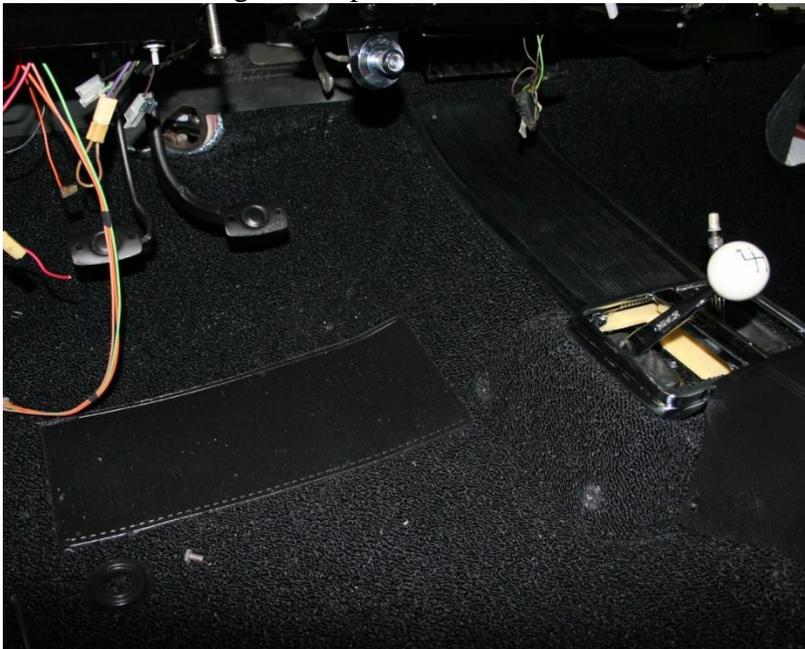
Fitting front carpet and console plate and shifter housing

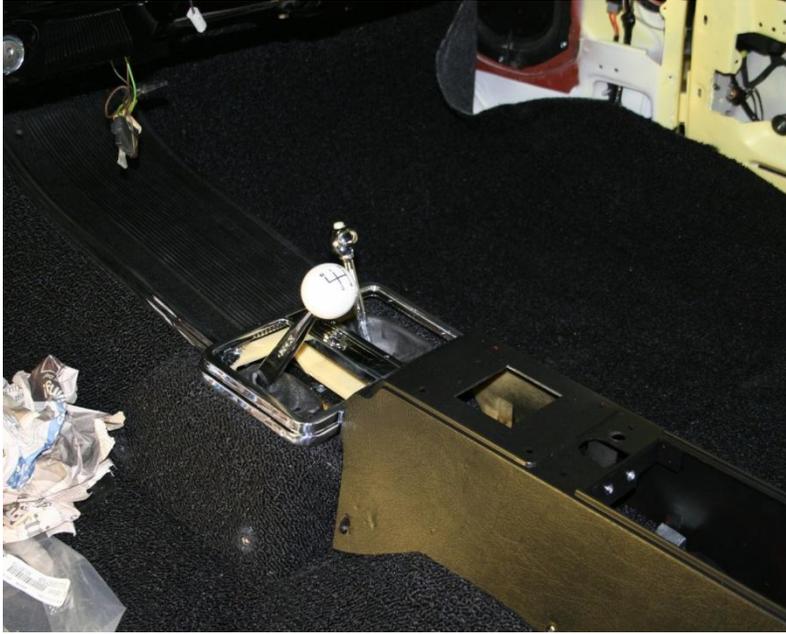
Middle console section installation on carpet

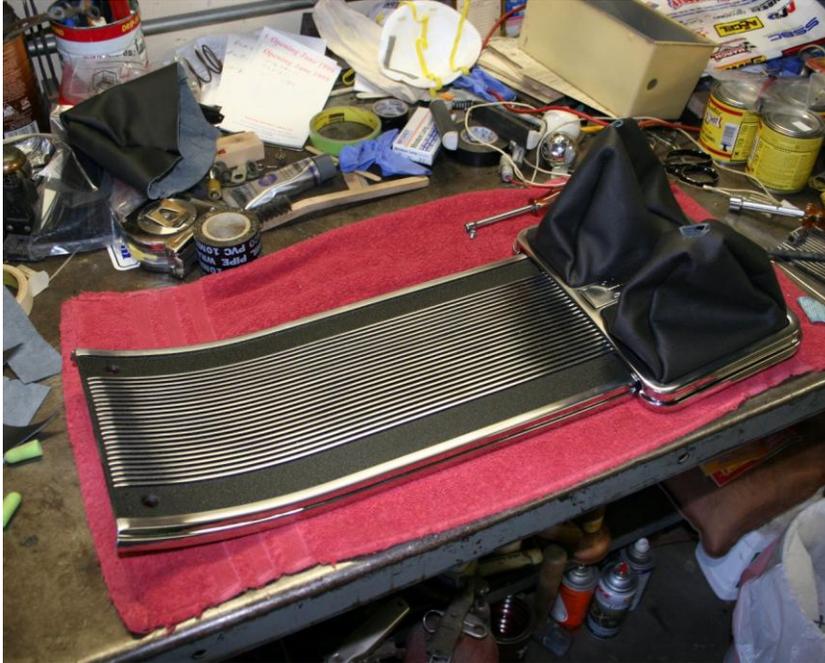
Shifter boots installed on the floor plates

I made a test piece for the shifter boot and now will have to make new ones for each shifter.

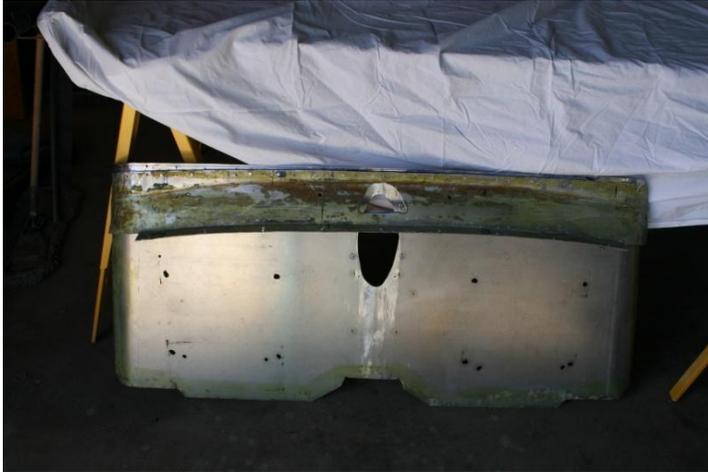
Metal back seat support plate

Continued fitting the carpet. I selected a sheet of the leather for the filler plate that was used behind the rear seats. The leather hide was cut for each piece similar to the ones used on this plate. I had them sewed up as they were on the original piece. I stripped the old leather off the plate and cleaned it up. Then I realized that a rear speaker was never installed on this plate. The speaker was just stuck under the plate in the rear and was hooked up but not sure how anyone could have ever heard it. I decided to finish the installation in the rear plate. There was a grill in the top of the rear console that looked like it was to be used for a rear speaker. I had a speaker that would fit in this area and under the metal extension in the rear. I cut the hole and attached the speaker. It did require a clearance hole in the body back plate. The leather was glued to the plate and all holes cleared. I attached the metal frame that held the speaker grill. I used original holes to attach everything to the plate. This should let all the screw holes in the console center piece to work.

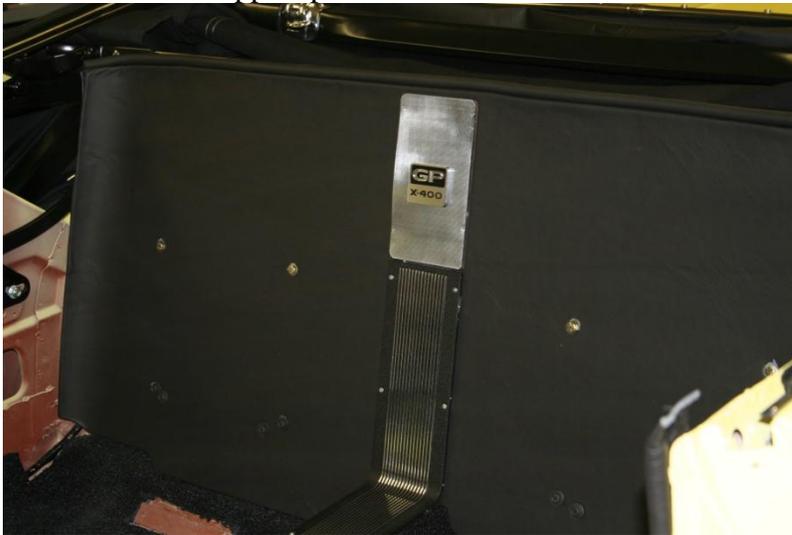
Back seat plate leather covered and part of console in place

Feb 9 Installed the metal-leather covered sheet to the back seat bolts. After a lot of adjusting, finished this installation and could now install the console center section. There were a number of screws broken off in this center piece where screws held the trim on this center piece. I set the piece up on the mill and drilled each screw out and tapped the holes. The center piece was then fitted to the console floor pieces and the rear plate. All the holes matched so far and all looks ok. There is an emblem on the rear speaker cover. I took this apart for cleaning and painting. It was interesting to see how it was made. The letters were separate pieces and the metal insert was milled out for these letters to fit and all of these were attached with studs and screws. I got them cleaned and painted. After cleaning and assembly I screwed them on to the seat back plate.

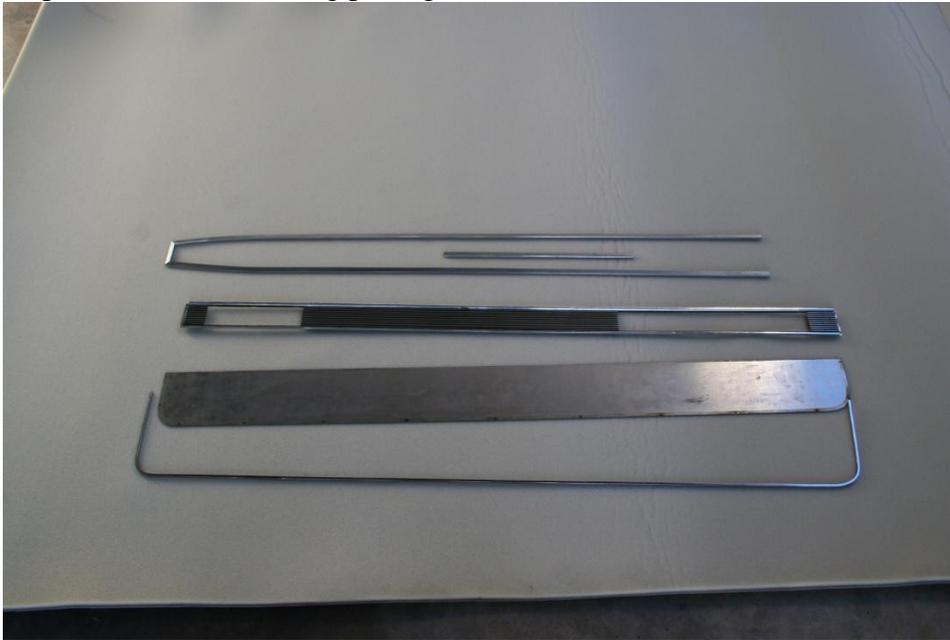
Feb 16: Worked on the chrome trim for the door panels. There were many broken studs in the trim pieces. These pieces are made of brass and plated, the screw studs were steel. Since the door panels were not water proofed, these studs rusted. After looking at the pieces I decided to redrill the holes, offset from the broken studs. This meant drilling holes in the brass plates that were wrinkle black. This took most of the day; I used the mill to do this drilling and tapping for the 2-56 studs. I got all the plates and trim repaired and ready to go the plating shop. I ran the tap through all holes and installed screws to keep the holes clear during plating.

Metal pieces for one door panel

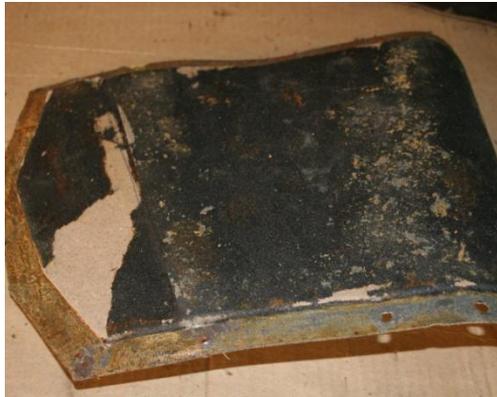
Original panel leather

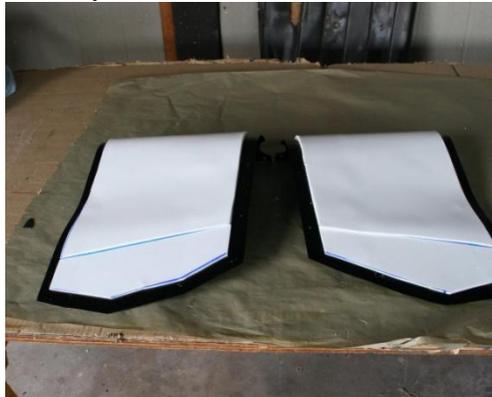
New padding

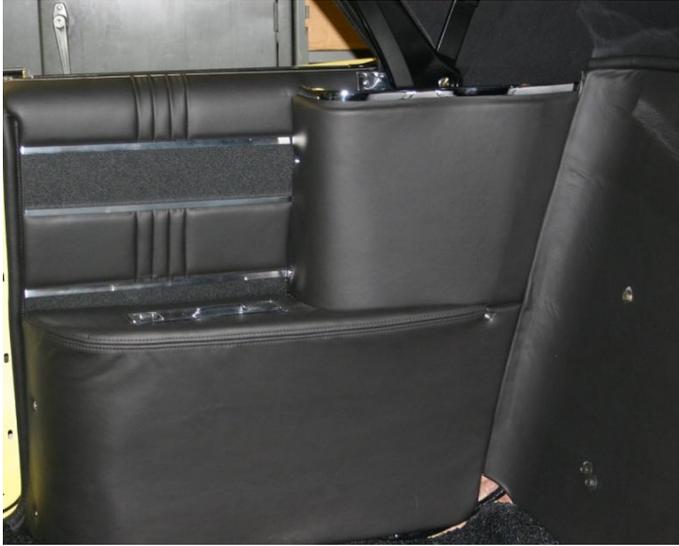
Finished piece

I then fitted new leather to the top and bottom arm rest parts. Only the outer edges were cemented to the metal pieces and floated on the foam covering. I fitted the chrome pieces to the rests.

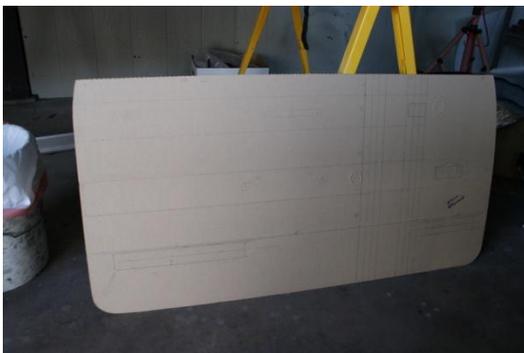
Panel layout

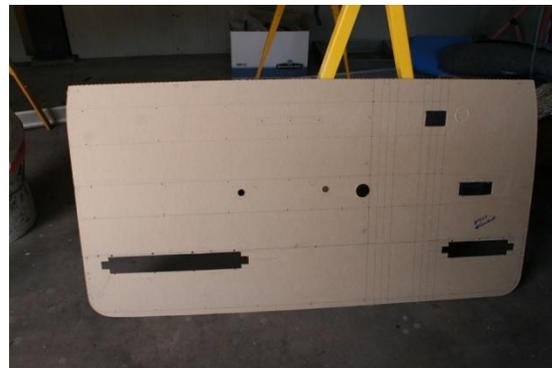
Holes cut out

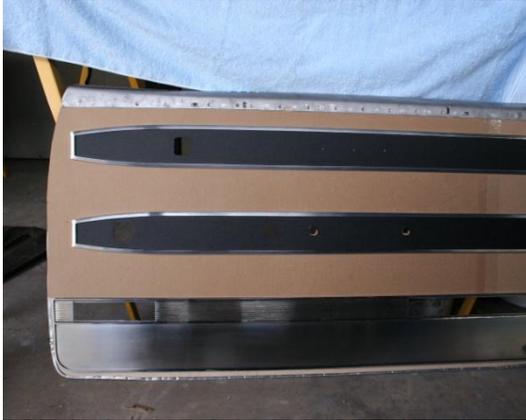
Metal trim attached

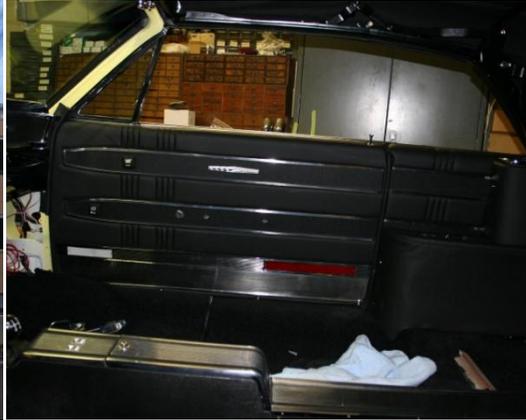
Finished panel installed on door

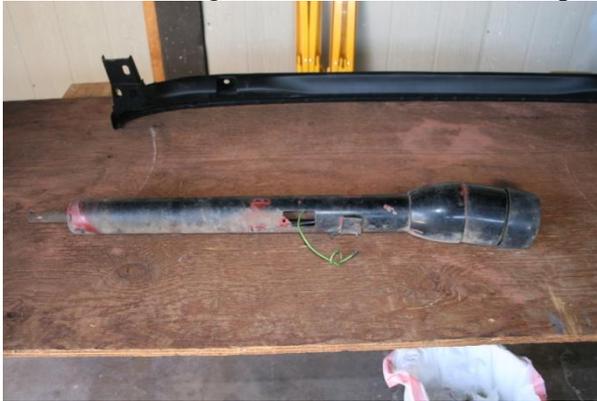
Next I took the steering column apart. This is a tilt column and it takes some care to disassemble this item. All the grease was hard and it needed to be cleaned. The metal shaft and housing needed to be cleaned and painted. The photos show this work.

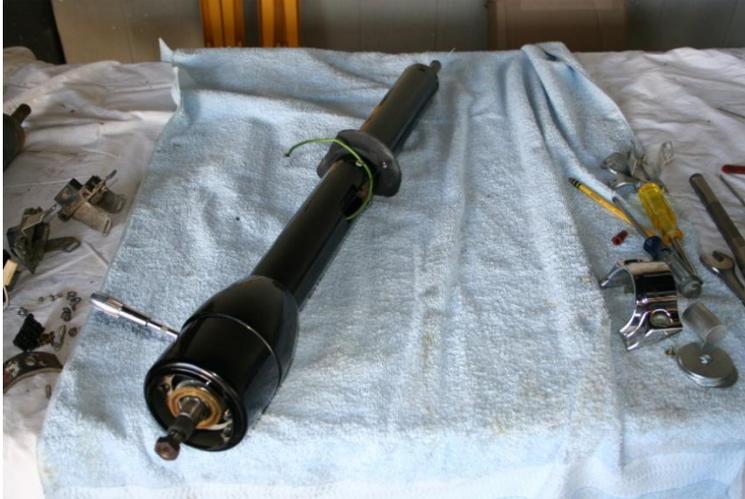
Column ready for installation.

All the steering column parts were painted and the assembly put together with new lub.

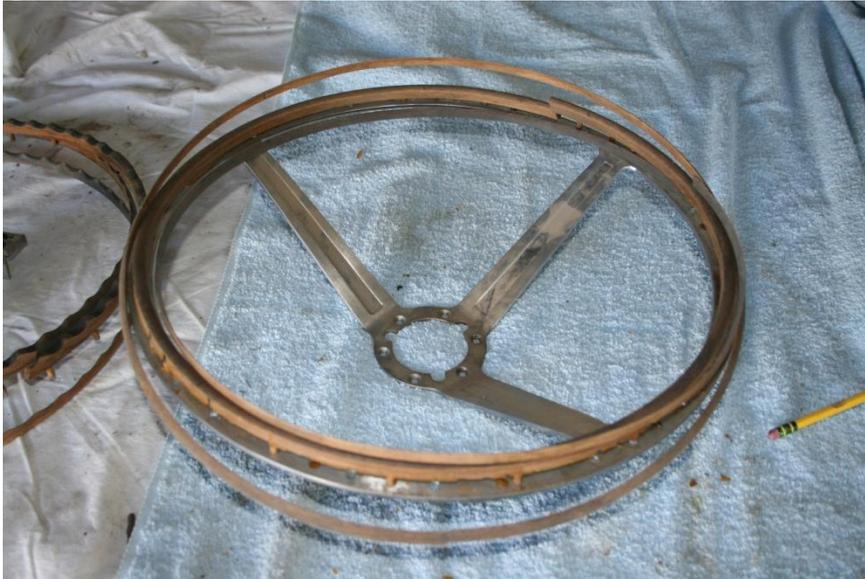
The steering wheel was in very poor condition. It is a walnut wood wheel and had come apart. This will take some work to fix.

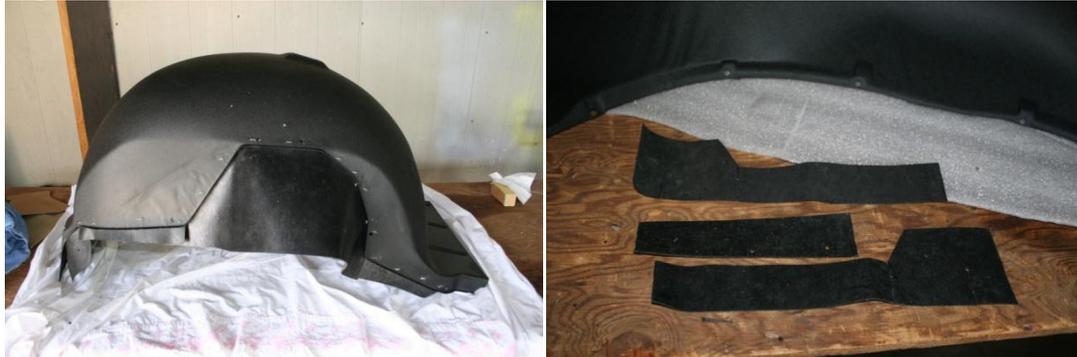
Finished fender well with splash guards      Rubber splash guards

The fender wells and support were wrinkle black so I had them blasted and power coated to get a uniform wrinkle finish.

The rubber splash guards are no longer available so I had to make them based on what I had left from parts cars, These were fun attach using staples and gong through the holes in the fender wells.

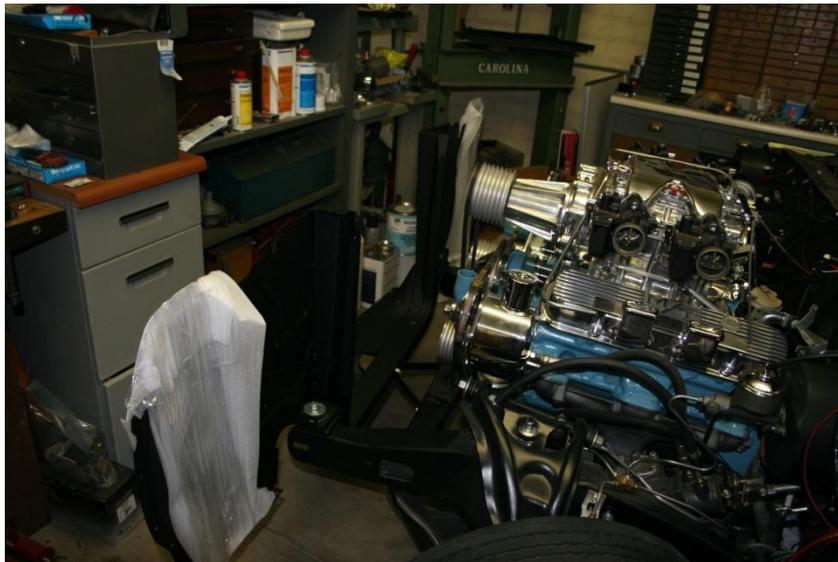
Radiator support in place

The assembly of some of the front end pieces began. I first set the radiator support in place on the frame and got it attached loosely so it could move as the fender wells were attached.

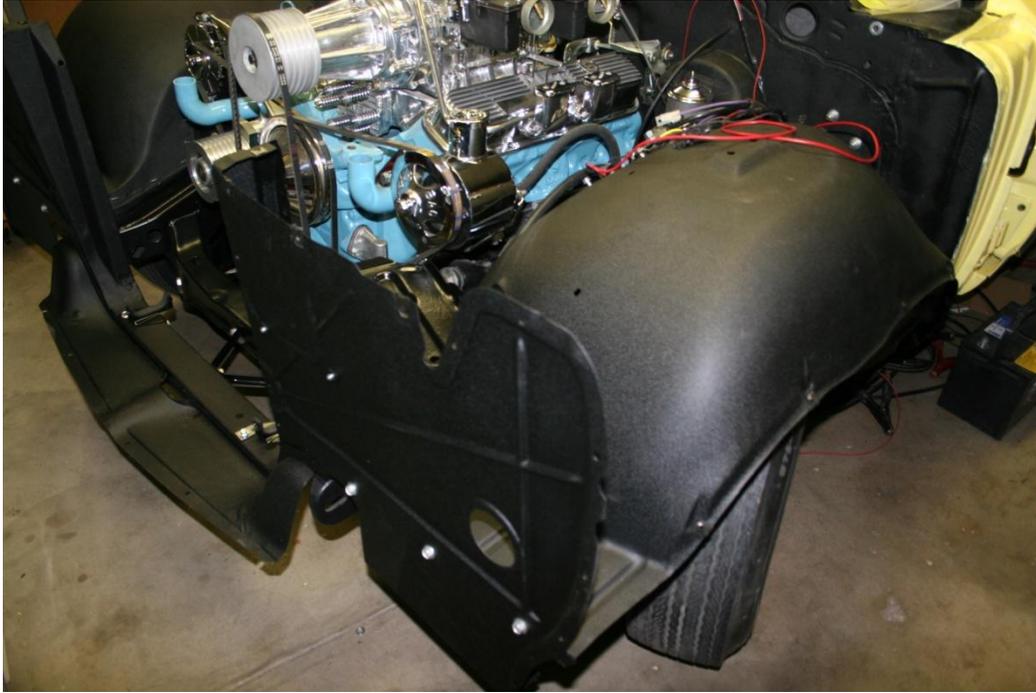
Next I attached the driver's side well and loosely bolted in place, then the passenger side was installed and all of these part tightened down for now.
