2012

Jan 1 to 15

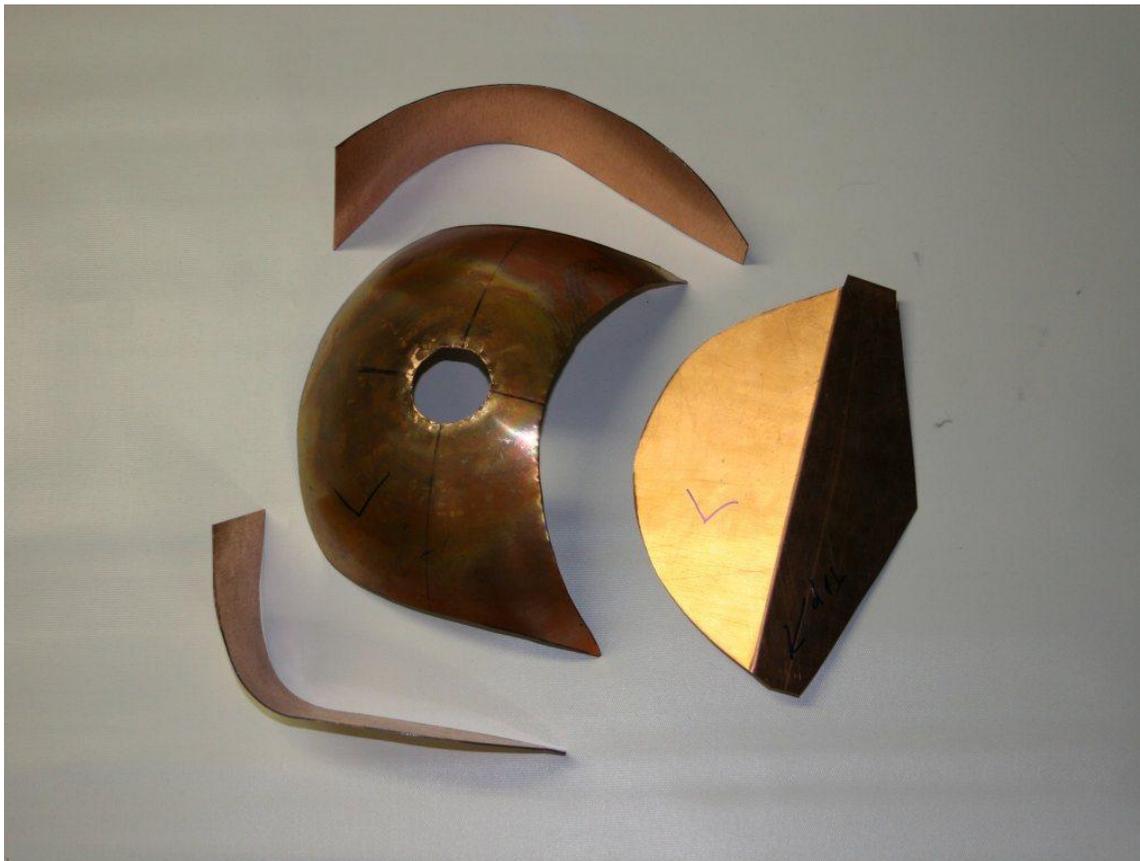
Copper parts first trial.

Feb. I designed and cut the copper to make the tail light housings. In order to weld them I finally installed a new power lines to the shop to handle the tig welder. This took several weekends to complete. When I got this done I tried to weld the copper together. It proved to be a challenge due to the heat needed to make good welds. And I had two different thickness pieces of copper to join. When got hot enough to weld it would blow out and then made a repair nearly impossible. I had Dave look at it and he also concluded it will not make a nice housing for the car. So I am going to try another approach and see what can be done.

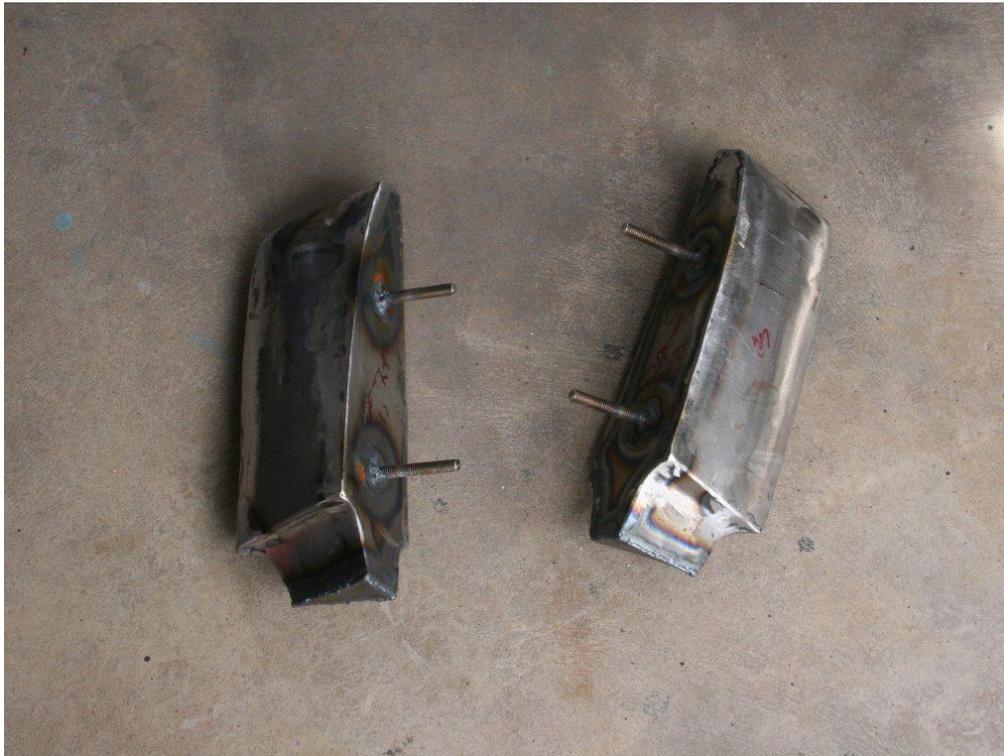
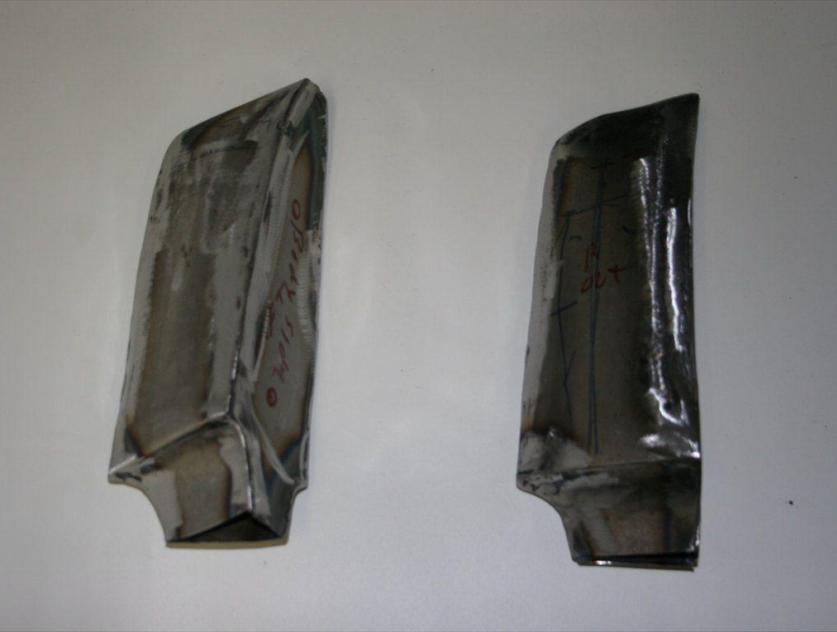
While I waited to see what I could do with the tail light housings I started another area that needed a part on the body. GM called this the Grand Prix x400 and some of the items or styling parts of the Grand Prix production car were used on this body. On the rear of the car where the taillights are installed, in the Catalina and Bonneville, they installed a casting filler piece to finish the body. These were attached by bolts and had a seam with a rubber seal where they attached to the body. If you look at the photos of the X400 you can see there is no seam at this part or where they attach. From what I had left of the back end GM styling made a sheet metal part that was welded to the body. I used the castings for patterns and hand generated the two parts. I was able to weld them with the TIG which made nice welds. It took a lot of finish work to make them correct. I plan on attaching a stud to these parts to go through the body hole and then weld the part to the body and lead the seams. This stud will be used to hold the taillight housings in place.

I welded the new tail extension on the body. I used studs on the extension to hold them in place while I welded them on the body. These studs will be used to hole the tail lamp housing on. After the welding I tined the surface and applied the lead to fill in the weld joints. I used the lead to take care of any low places in the extensions and the filed this down for a finish surface. I made a fit check with the rear bumper to make sure all was in the correct place.

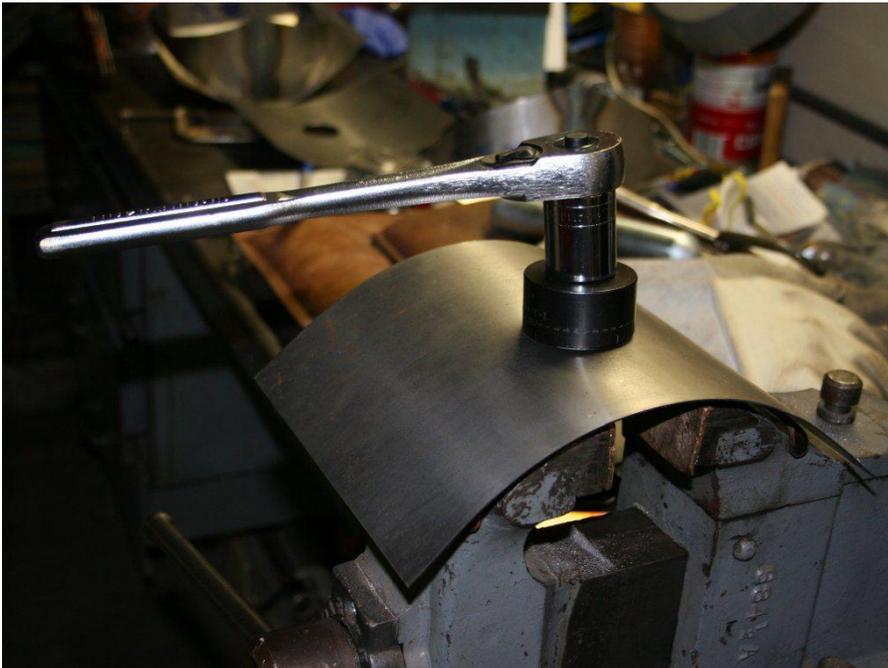
Steel tail lamp reflector back hole for lamp

After trying to get a good weld with the copper parts for the tail lamps I found it was taking too much heat to get a good weld and when I got a good weld it only lasted for a very short time and the copper conducted too much heat too quickly. Since I did not have any facilities to keep the copper parts hot I decided to do a different design and go to a parabolic curve and do a fit to the side pieces I had designed and make it from steel. This turned out to be the answer. So I made the parts and welded them together. I then fitted them in position and made extensions on each

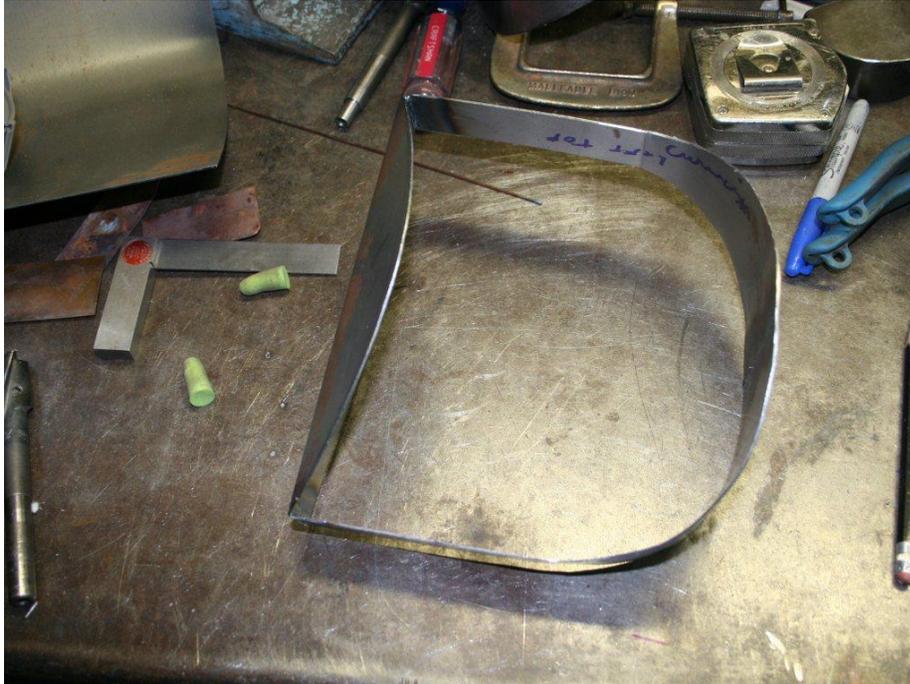
Finished housing for tail lamps

side for mounting. I now have to check the fit with the tail lamp grills and see if we have any problems. If all of these fits are ok I should be able to do the finish work on the body and start shooting the paint.

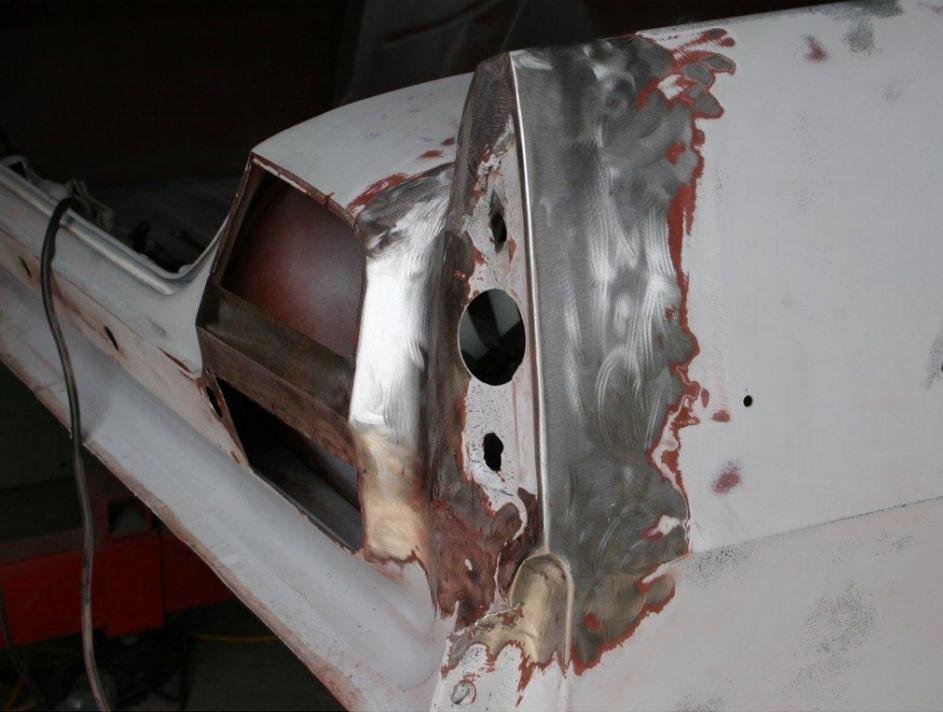
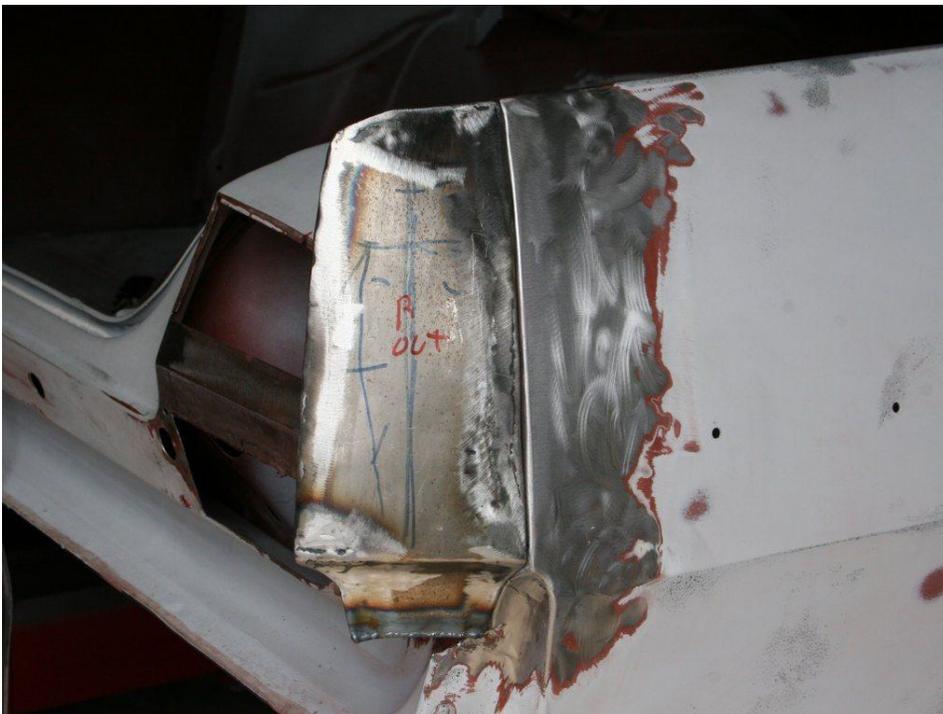
Fit up of the part on the back end of the body

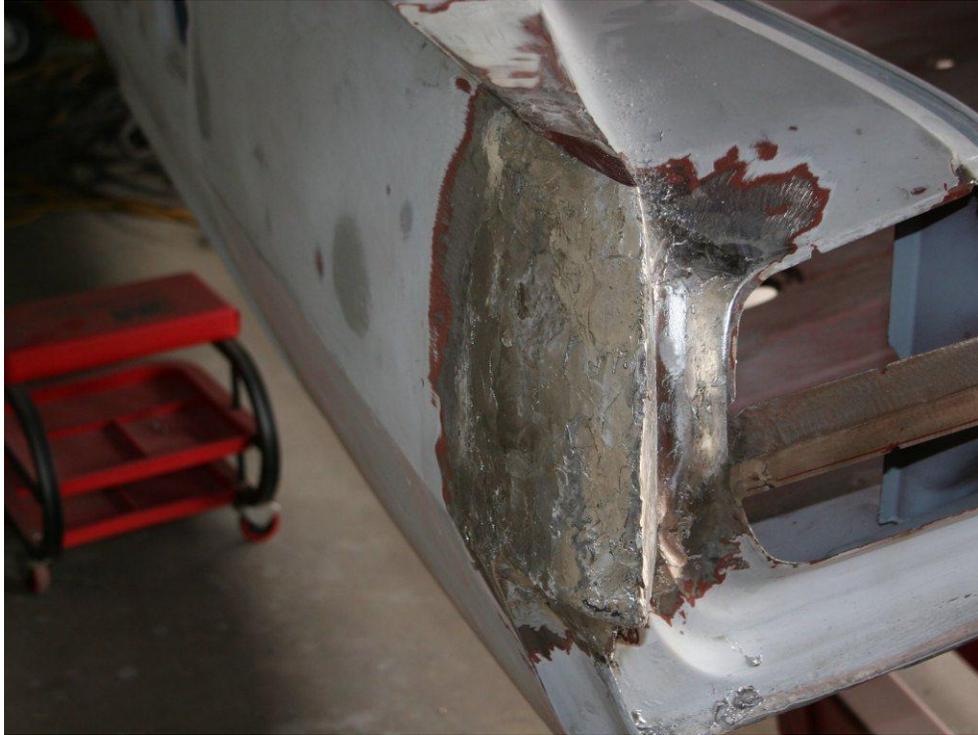
Side leaded in for finish.

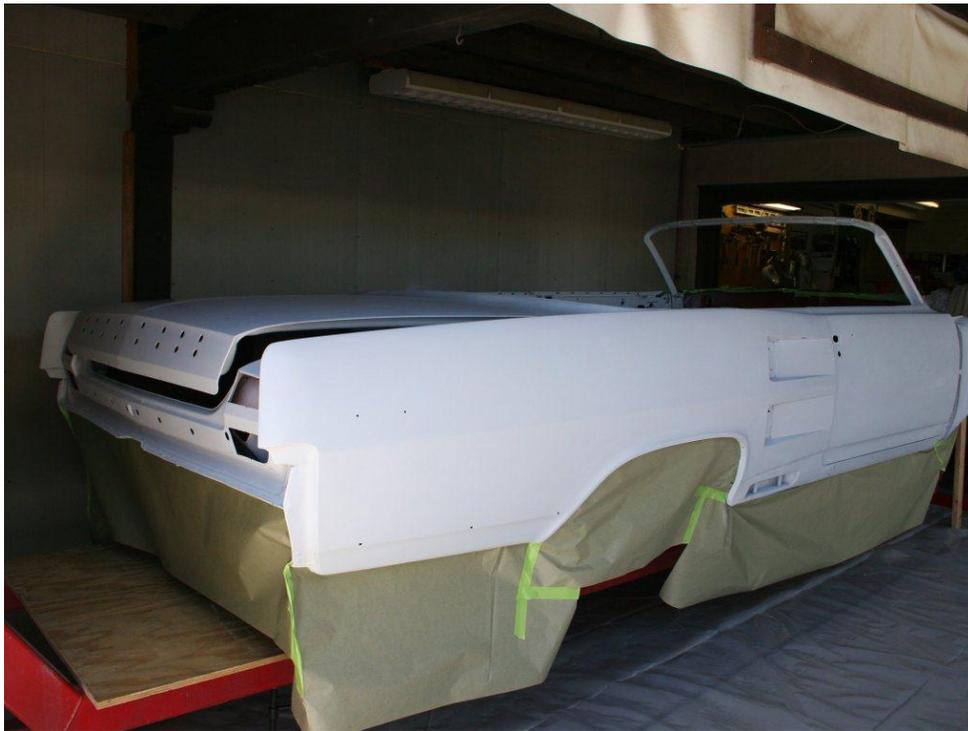
Body primed after finish of rear parts on body

The body was sanded and sprayed with K36 PPG primer. I used a black spray to make a guide coat and then sanded with a large hard flat block. This revealed places that were very small dimples in the sheet metal. These were either sanded out (until I saw the red base primer) or were filled with polyester glazing putty. All of this sanding was done by hand to make sure all surfaces were as flat as possible. Then another coat of K36 was sprayed and sand once more with a guide coat. After all small defects were take care of a final k36 coat was sprayed. This last coat was reduced more to flow better. This coat was sanded with 400 grit paper and all looked good. The body was completely washed out and all area cleaned. It is now ready of top coat.

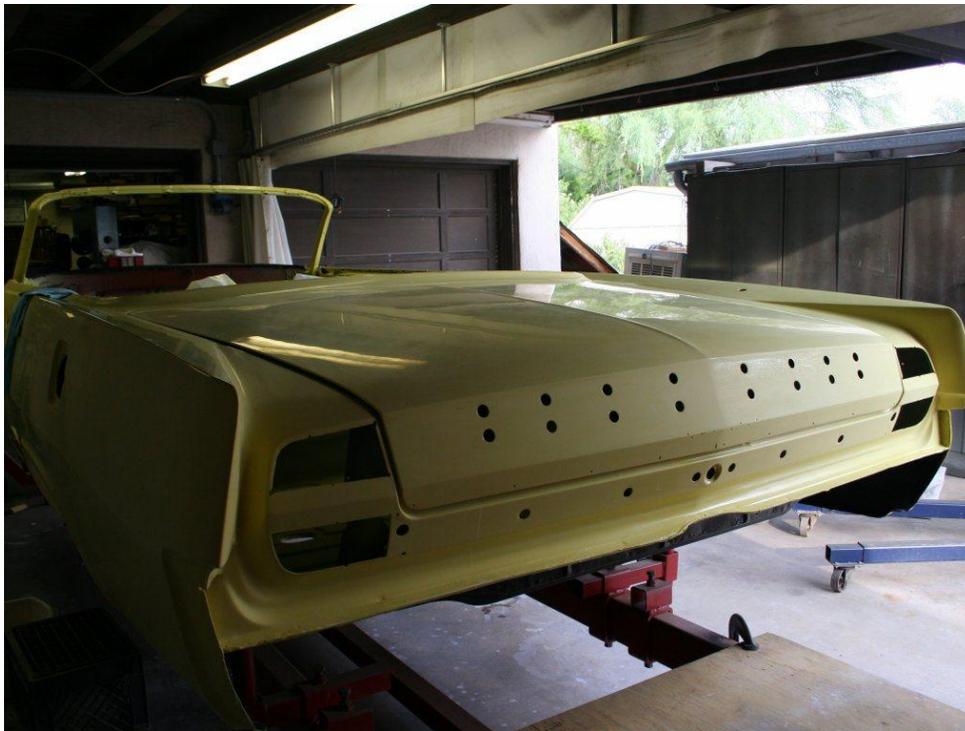
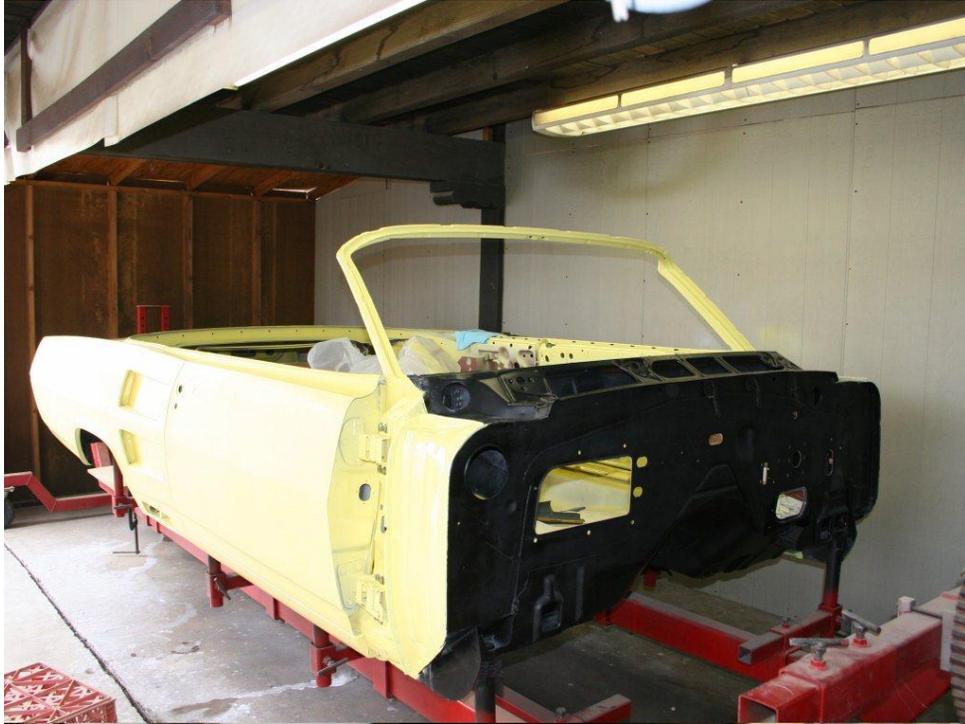
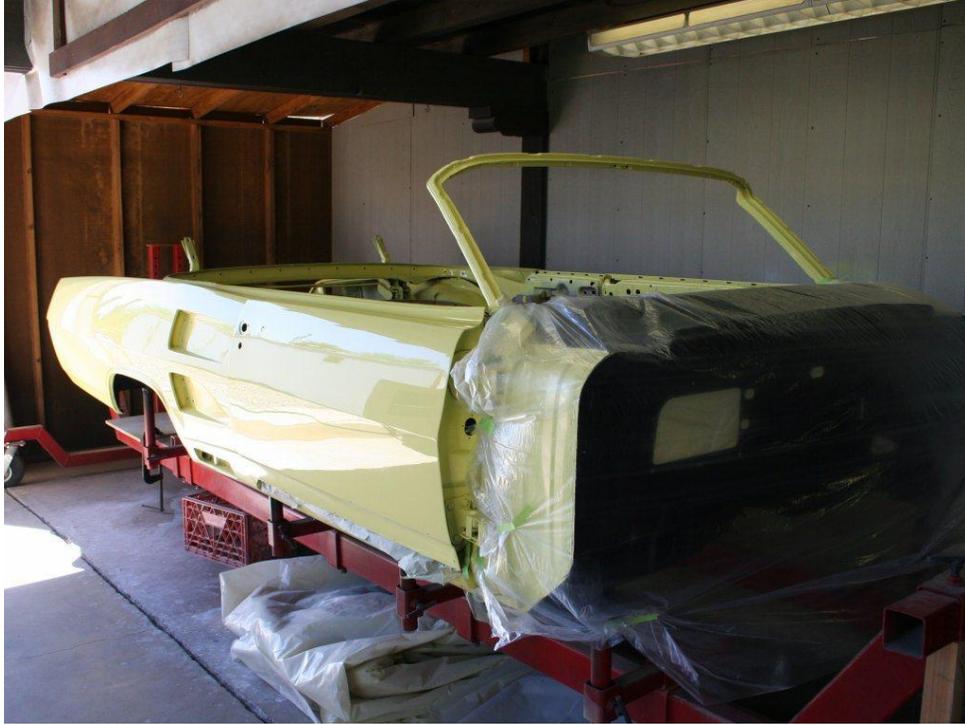
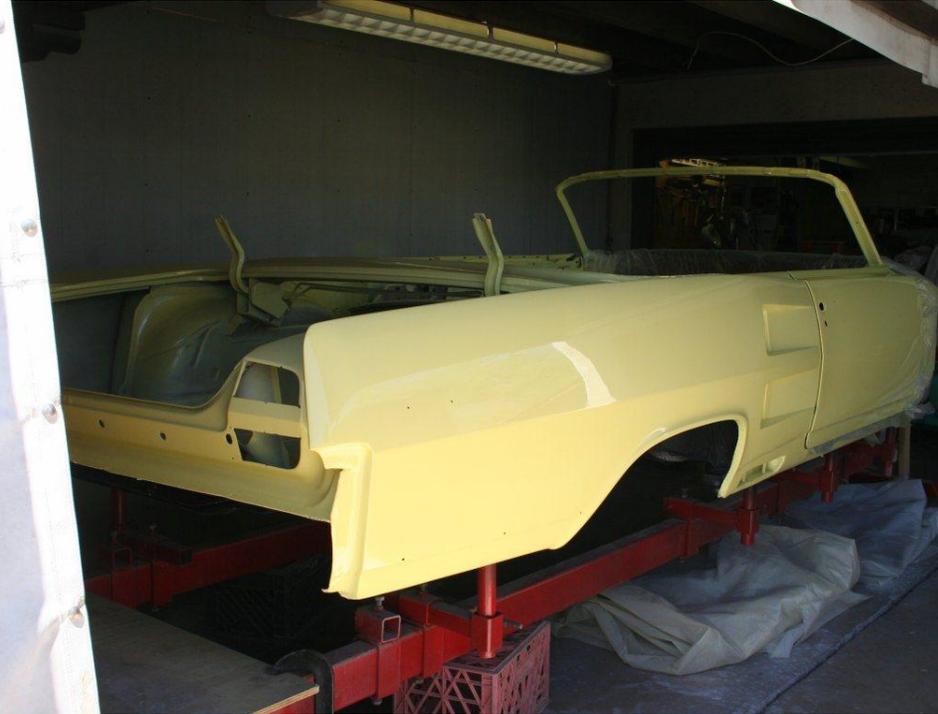
After the final primer and sanding I got the body ready for the finish. I went with PPG color/clear coat. I masked off the under carriage and fire wall which were finished earlier. Since I was not sure if we would do a pearl finish, the doors and trunk lid were left attached to the body so all would match. This later proved to too much to do and requires more spraying. I sprayed the color and then did 4 coats of clear to allow for sanding and buffing. When I finished I saw two places where the air hose I was using for my breathing mask had contacted the clear coat on the quarter panel as well as some dirt blew out of the trunk lid structure in to the clear as well.

I sanded down the clear after a day or two and then removed the trunk lid to do later. I then resprayed the color and sprayed nearly 6 coats of clear. This went very well. I then sanded and buffed the coat. The clear went on so well that I used a wooden block and 800 grit paper and water with some soap in it and sanded the surfaces to flatten them out. This was a very light sanding. This was followed by 1000 and then 2000 as a final sanding. I then buffed the finish with my power buffer and 3M Perfect-It III rubbing compound. I then buffed with Perfect-it III glaze and then 3M Finesse-it II finishing material. This gave me a glass like surface and very deep finish.

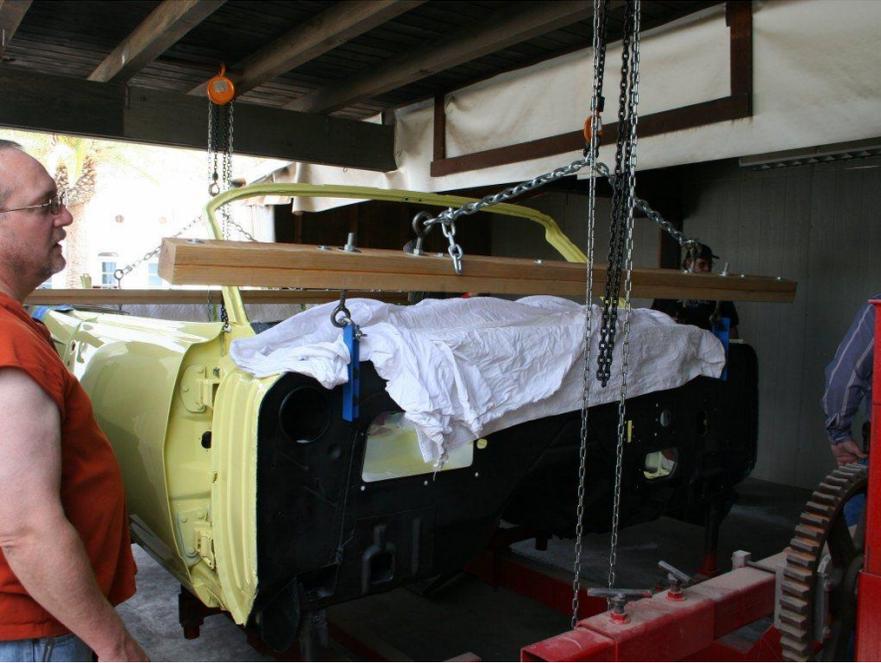
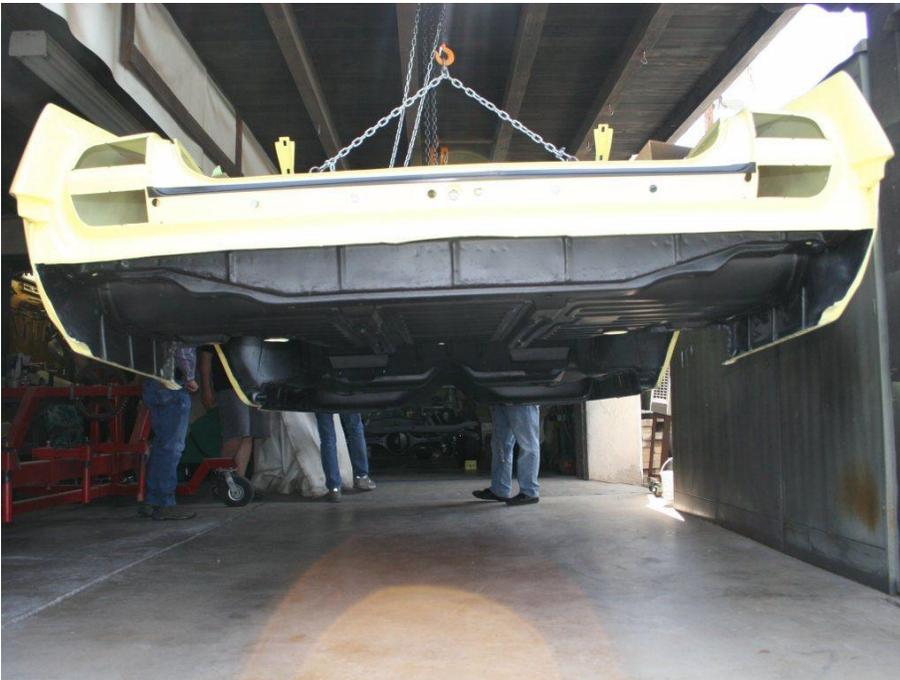
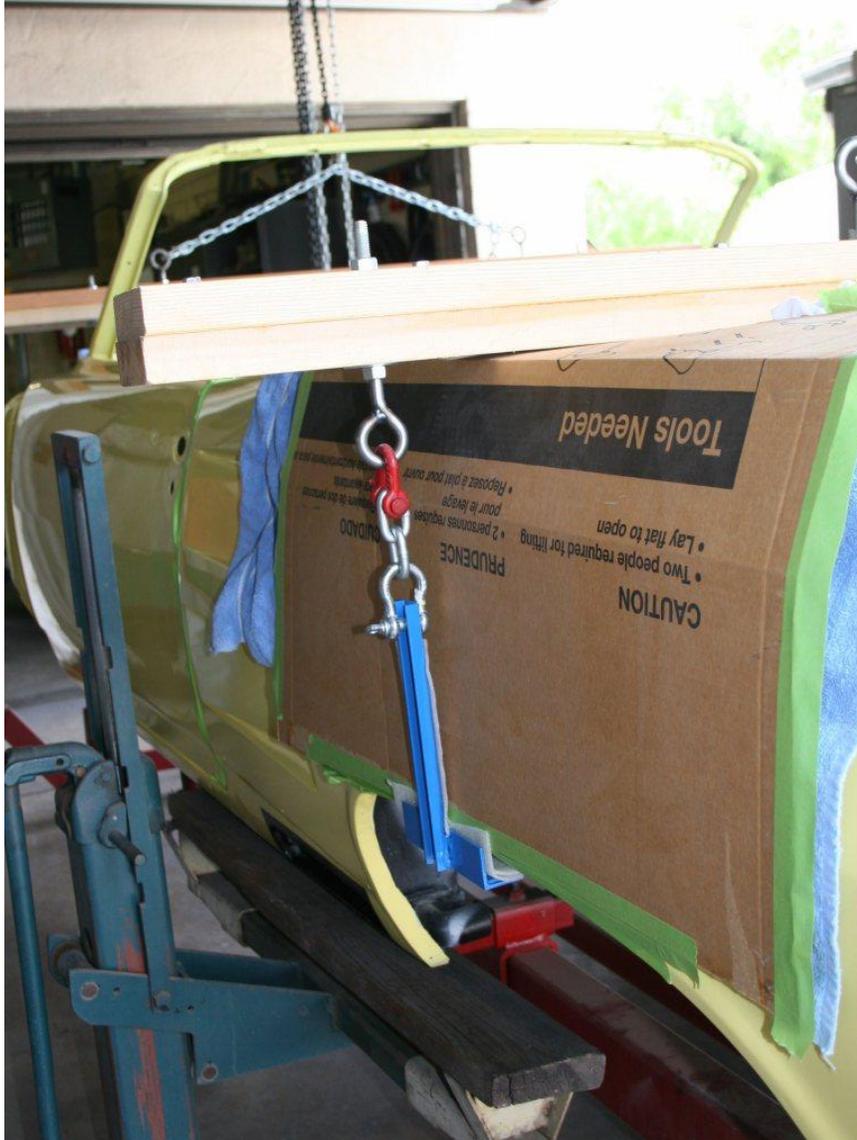
This was the big day. I was able to get a number of people that I work with to come over and we moved the car cradle over to the next bay of the car port. I padded the sides at the quarter panel so I could use the lifting fixtures I used to remove the body from the frame.

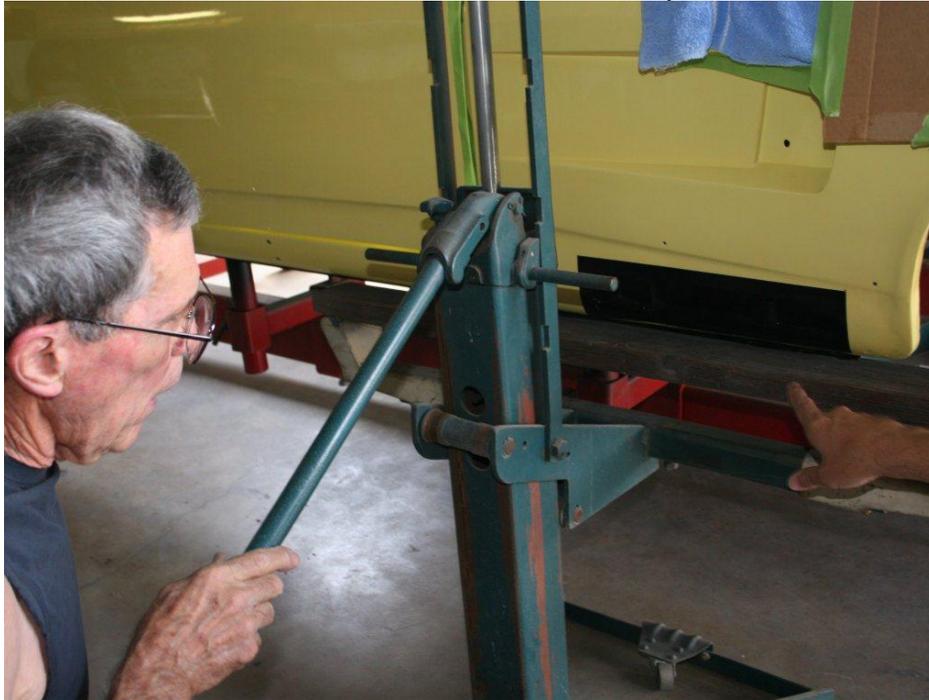
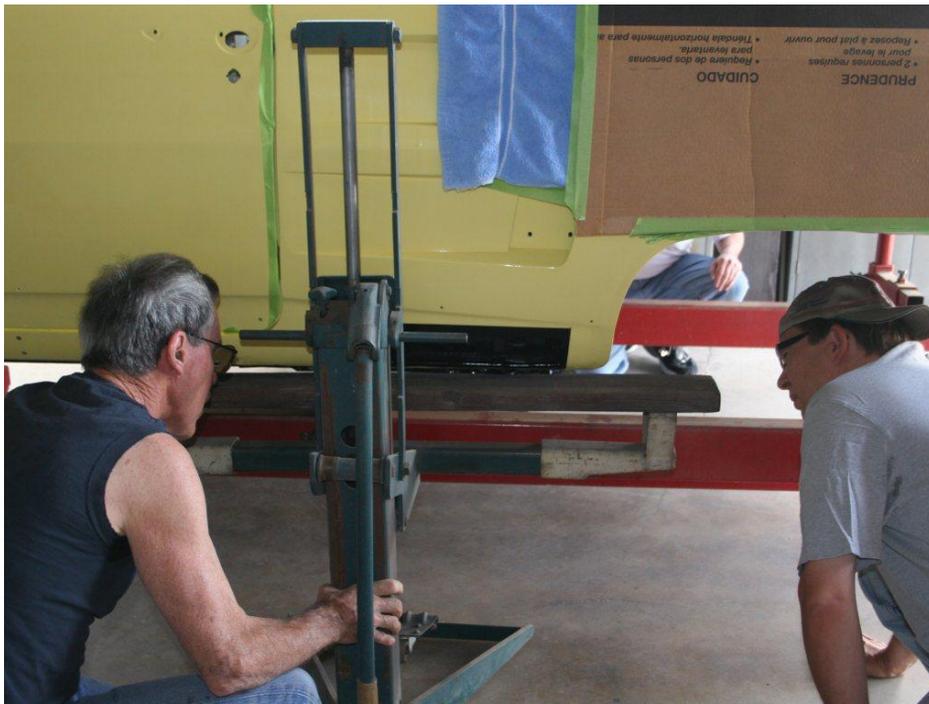
A concern was that I did not want to lift the cradle as well. This would be too much strain on the body. I used my bumper jacks that I used in the past under the rockers to lift the body. This took

the load so I could remove the cradle hardware safely.

I then could use the lifting fixtures on the fire wall and the one on the wheel well openings to do the lift. This work out well and the body was now free to roll the frame under. We rolled out the frame and with everyone watching carefully lowered the body.

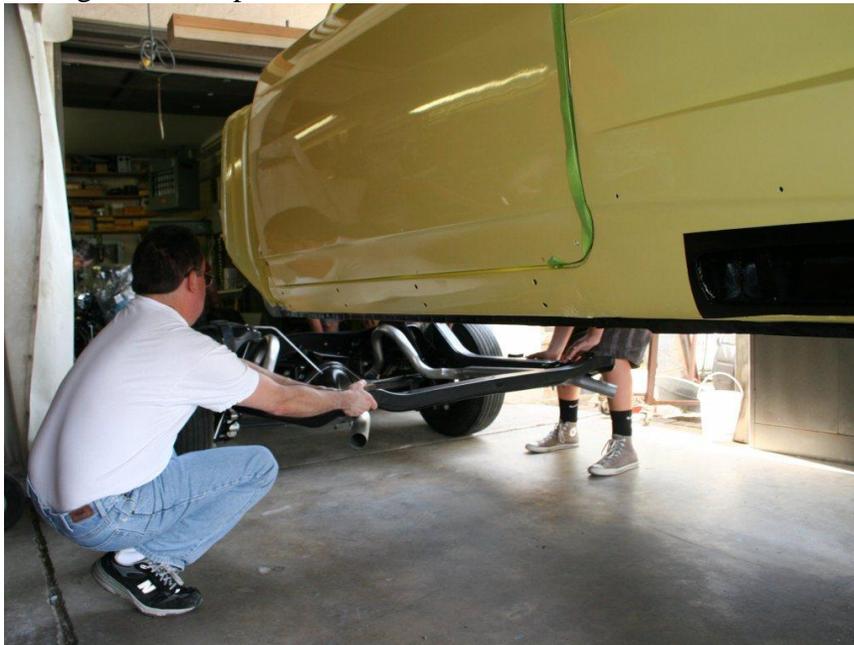
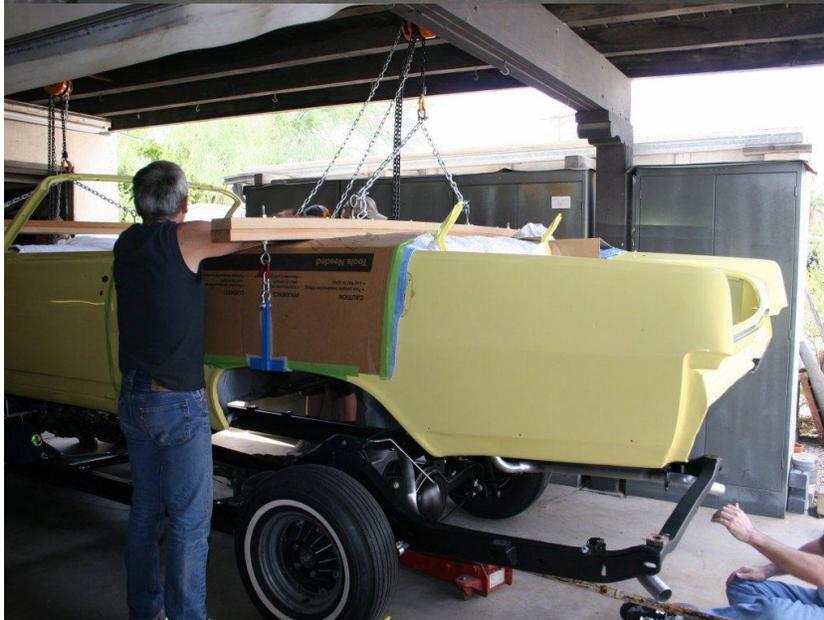
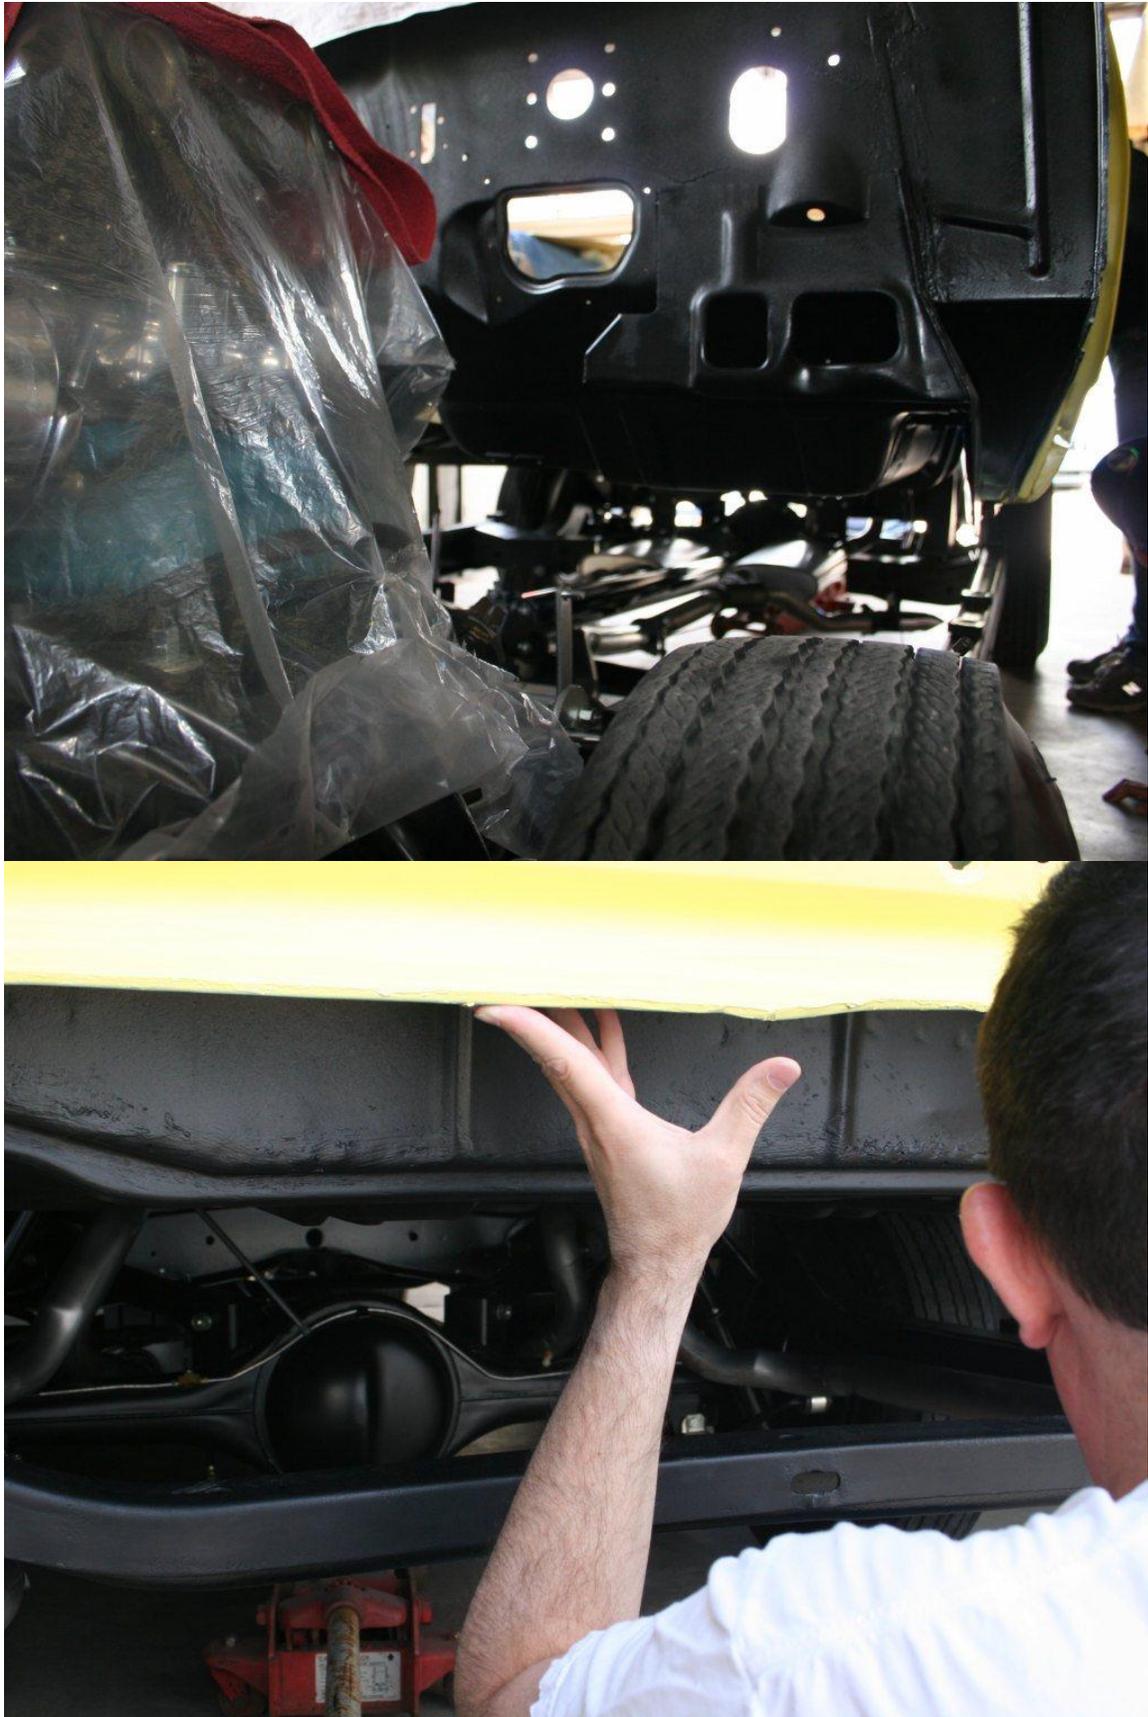
All went well. I did have interference with the shifter and exhaust control. Both will take some adjustment and cutting to get a good fit.

Exhaust cutout lever starts to show through the floor

I later found that the tail pipes were contacting the trunk back so they will need some change. We pushed the body and frame back into the shop. After cleaning up everything I measured the position of the body to the frame and all sides. I loosened up all the bolts and moved the body till all the measurements were same side to side. All the bolts were installed and tightened down to see how the body would change. Shims will be needed to correct the door alignment, but all looks good at this point and I need to install the trunk and see if it changed any.

I spent a lot of time working on the exhaust cutout control. It needed to be raised and moved to clear the body as well as positioning it in the correct location in the photos. I had to design new mounts and nearly ended up replacing nearly all the parts I made earlier. Since I used an automatic transmission shifter for the exhaust cutout system, it had the curved sector that had a

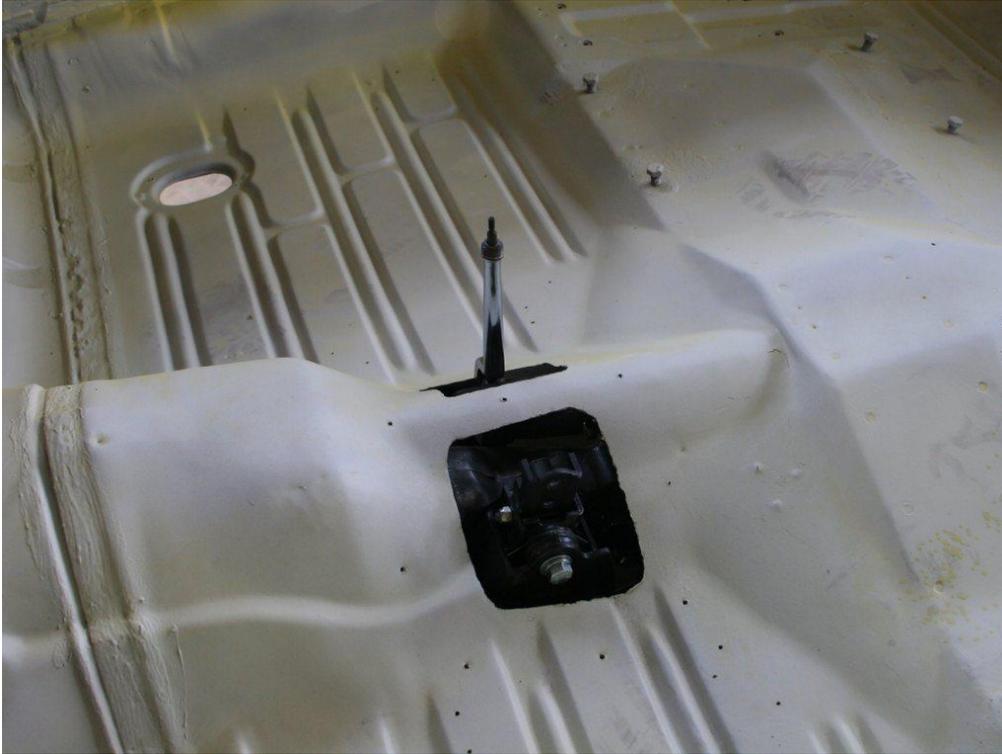
Exhaust cutout control lever appearing through the floor hole.

raised spot that was used to keep the shifter in Park and would not easily push out of place without pushing down on the knob on the shifter. The position of this shifter reversed this sector so the lock would be in the open pipe position. I removed the sector off the mount and welded it in a new location to keep the control moving in the correct arc and would lock in the closed position.. Now it looks correct and needs only housing surrounding it to cover.

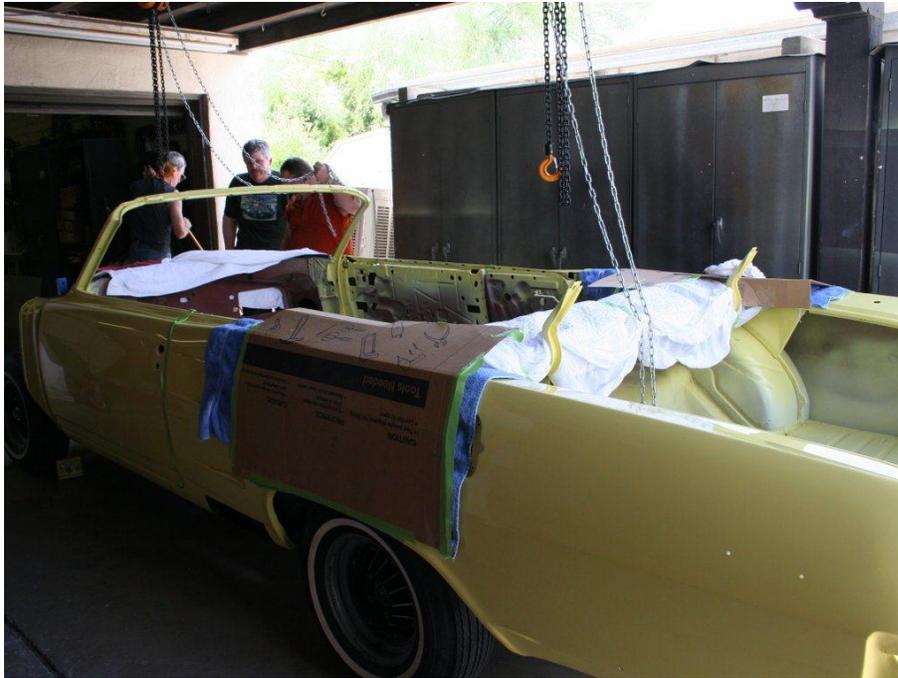
Body on the frame

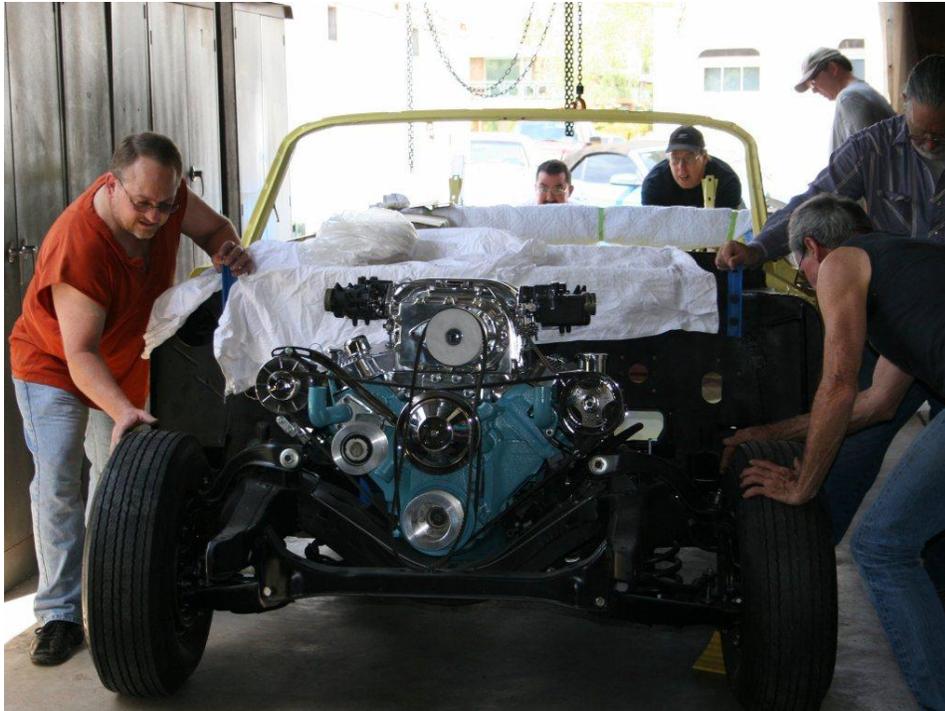
Ready to move into the shop

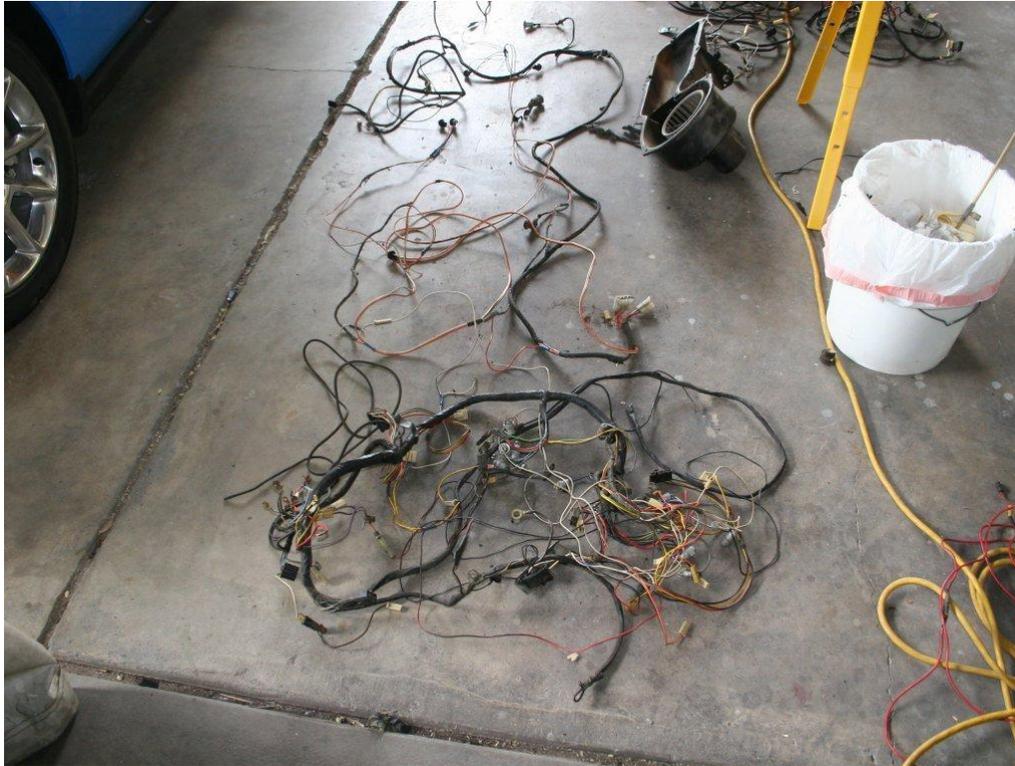
Original wire harness (A mess)

I did an inspection of the wiring harness from the car. They were a mess. This harness had been spliced and spliced. Changes had been done over and over until it was nearly impossible to tell what ran where. I decided to purchase new harnesses and convert them as needed to fit the car. I ordered the harnesses from M&H Electric in Calif. They had all of them available for the car and could supply everything but the fuse block. I pulled a fuse block off and old harness and sent it to them. The wiring harness came in and they look great all the color codes match the codes in the manuals. Had to get a number of different section of harnesses for the entire car. The power vent window harness was one they did not have a pattern for so I sent the old harness and they made one for me. A fabric called mole hair was used to as a lining in the quarter window track. I had to make the rubber weather strips that fit on the top of doors and quarter between the glass and the door. I installed them on both the doors and quarters.

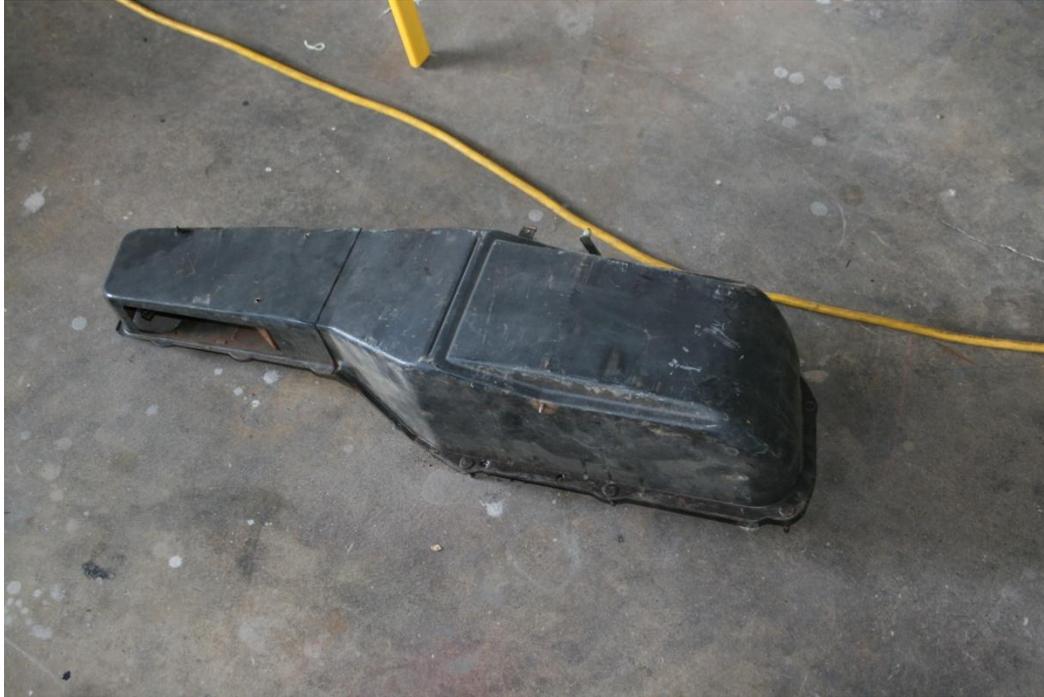
Heater box stripped of paint

I got the heater box stripped of paint and ready to be painted. I started cleaning the blower housing. I got the grills back from chrome plating, for the trunk and began to fit them. They are working out fairly well except for the center joint. The chrome built up on the ends and needed to be ground off for a fit. I ordered the fasteners for all the grills and the red plastic for the lenses. After the fit up I will use wide pin stripe tape for the black fillers. I used a precision cutter to cut the strips for the inserts

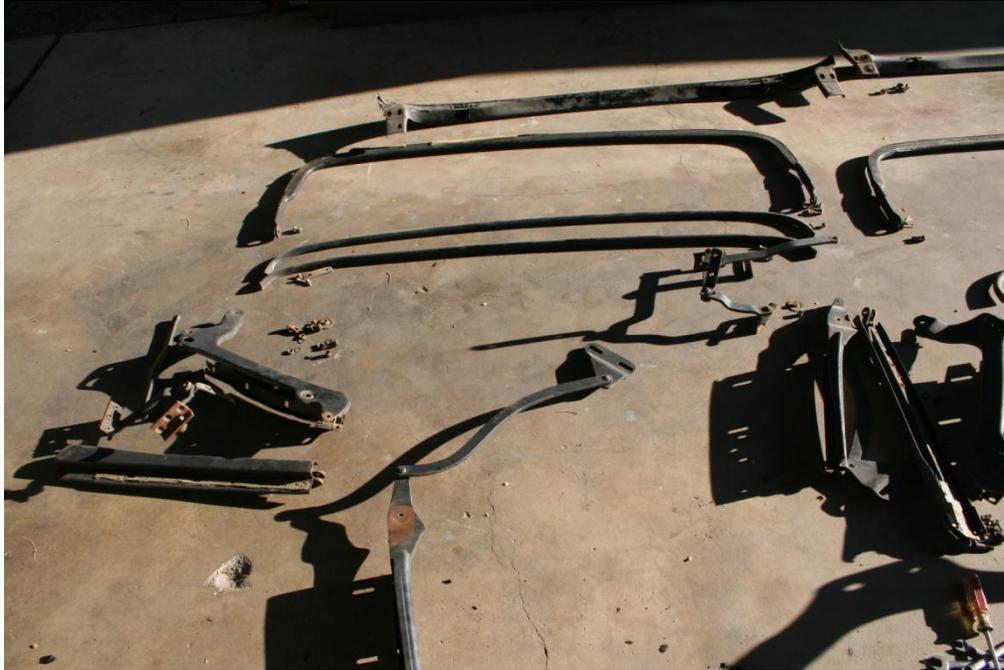
I took the convertible top bows apart and had all pieces sand blasted. I had a problem with the front bow. The first one I did had been hit in the center and was bent, but it was in excellent condition. I had the other two, blasted and both were in bad shape and would need a lot of work to repair. I decided to use the bent bow and straighten it out.

Convertible top bows before cleaning
