2012

Jan 1 to 15

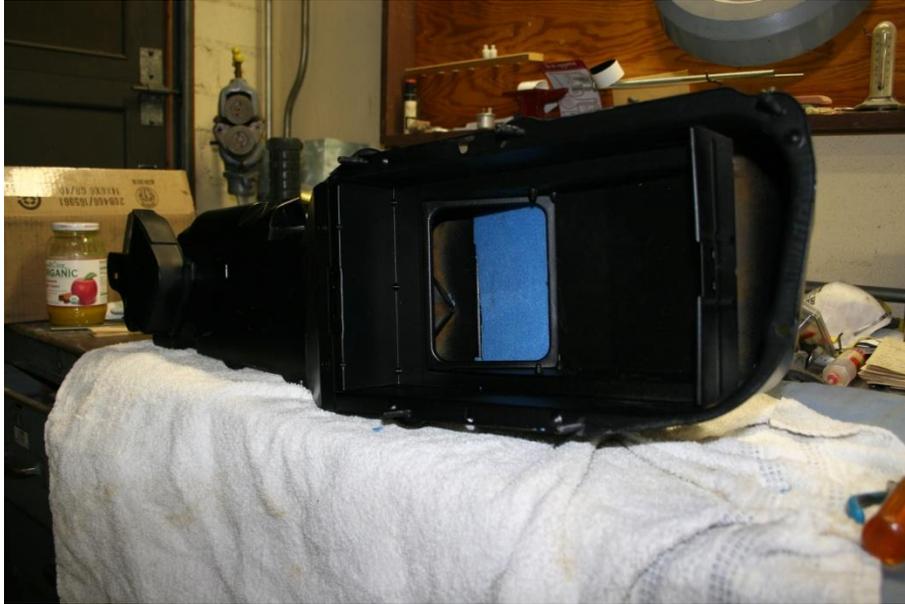
Heater core housing

Painted the trunk lid and rubbed it out. It was installed Mid November and lined up. The X400 letters are going to be a challenge to install and reach the studs and nuts to hold them on. Removed the paint on the heater and blower housings and painted them. The heater box had been painted with a satin black paint instead of the semi gloss gray. The blower housing was painted with a wrinkle black paint this has been a challenge to get a good coat. Installed some of the lower trim on the doors, quarter and trunk quarter area. The brush chrome looks very good and a nice match to what was there originally.

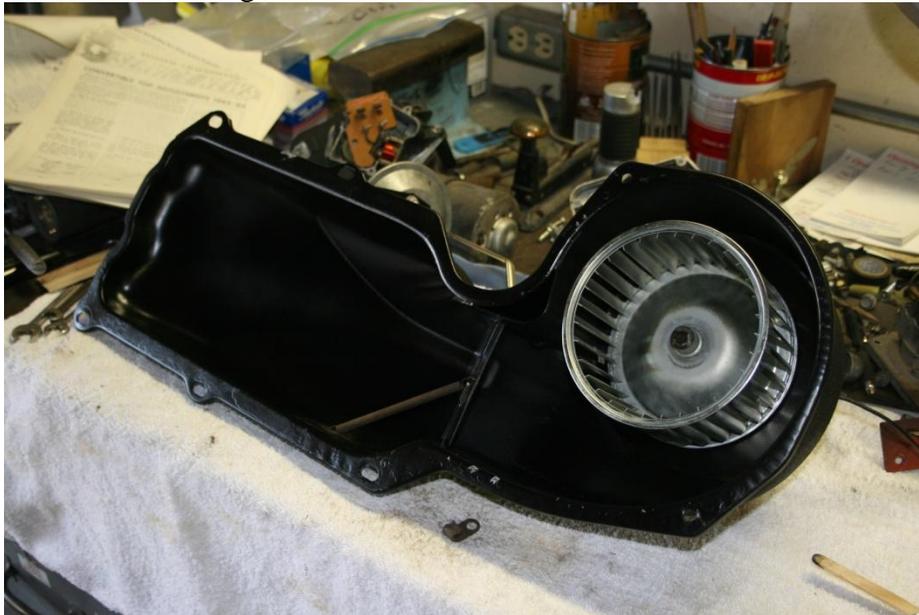
Blower housing

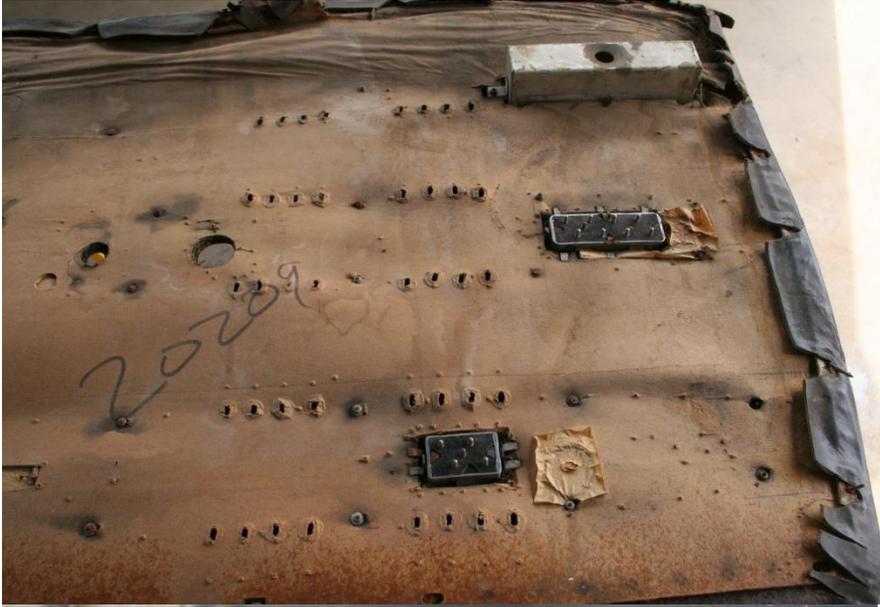
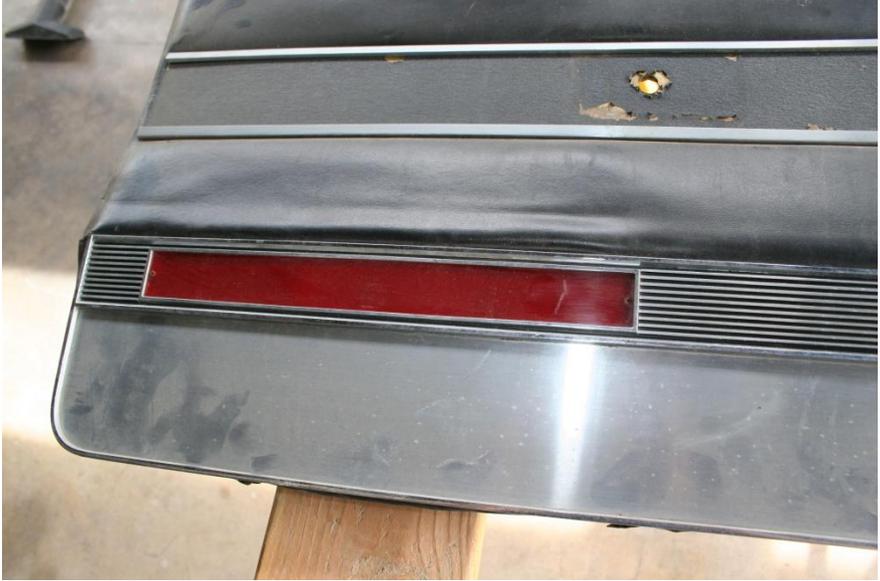
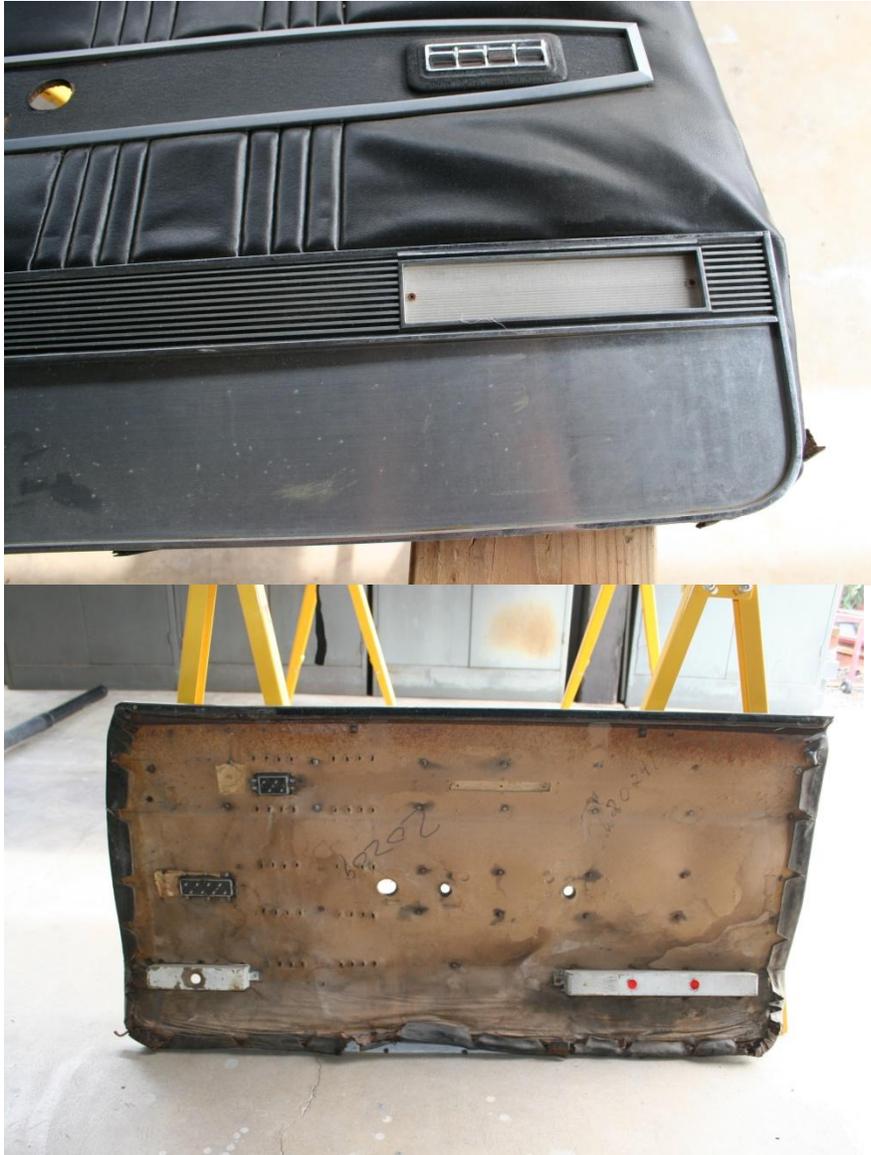
I took the door panels apart to see what I will need to replace them. Also the chrome will need to be redone on all the pieces. The panels were in very poor condition. The water barrier had been removed and water badly damaged the bottom of the panel to the point it could not be saved. The leather was in very poor condition and the trim not great. All the trim was brass pieces that were machined and welded together. These brass trim pieces surround a brass plate that was painted wrinkle black. These trim pieces were held on by 2-56 shafts with nuts and washer. I had a number of these studs break off in the trim piece so they will need to be replaced with new holes. I decided to use SS set screws for the studs. I will need to do the repairs and then get them to the plating shop.

Door panels

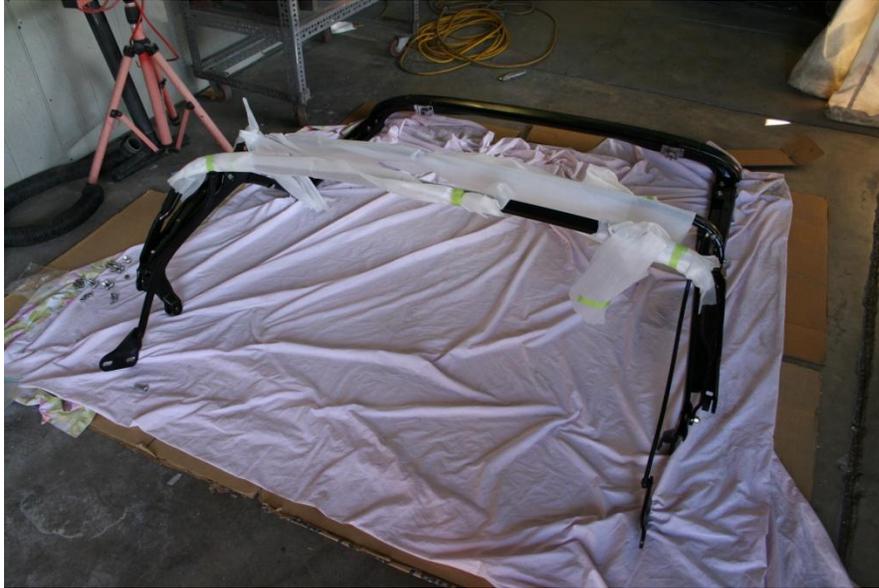
Top bows assembled and ready for installation

I had all the top bows powder coated to get the correct finish on them. The paint did not look good or hold up well during assembly. I worked on installing the wiring harness and got some of the lights fixed in place. Worked on door alignment and powered up the windows and began to line them up. Today I attached the top cylinders to the hoses and the rebuilt pump. I rebuilt the top pump several weeks ago. I then purged the cylinders and pump of air. I used a pump system supplied by Convertible Top Service in Calif. to prime the cylinders. The cylinders were attached to the top brackets and the system was installed in to the car. I ordered the leather for the interior. I need the leather so we can make the welting for the dash and leather for the rear plate behind the back seats. I ordered top from KEE top. I had no way of knowing what color the top was on the car. The top that was on the car when I got it in 1982 looked black but it may have been changed. I did get the build sheets from Pontiac Historical Services. On these sheets the car was built with a black top. Since I have never seen any photos with the top up, I went back to the black tops as this would look best on the yellow car.

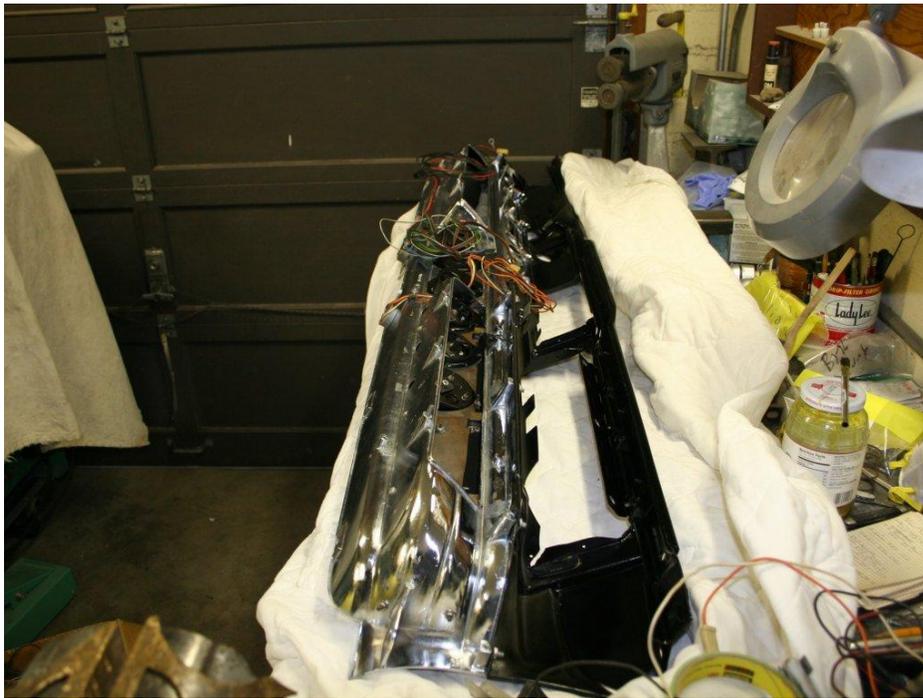
Dash rear before instruments were installed

Now that the top was installed I brought out the dash. I worked on the dash back when I got the car in the 80s. All in instruments were still in good condition and only needed cleaning. Fortunately and upper chrome part of the dash survived all the years of abuse and only needed cleaning. This was very good as the upper chrome part had been worked over a lot by GM to fit the instruments and trim. I painted the lower part and all the wrinkle black pieces. We placed

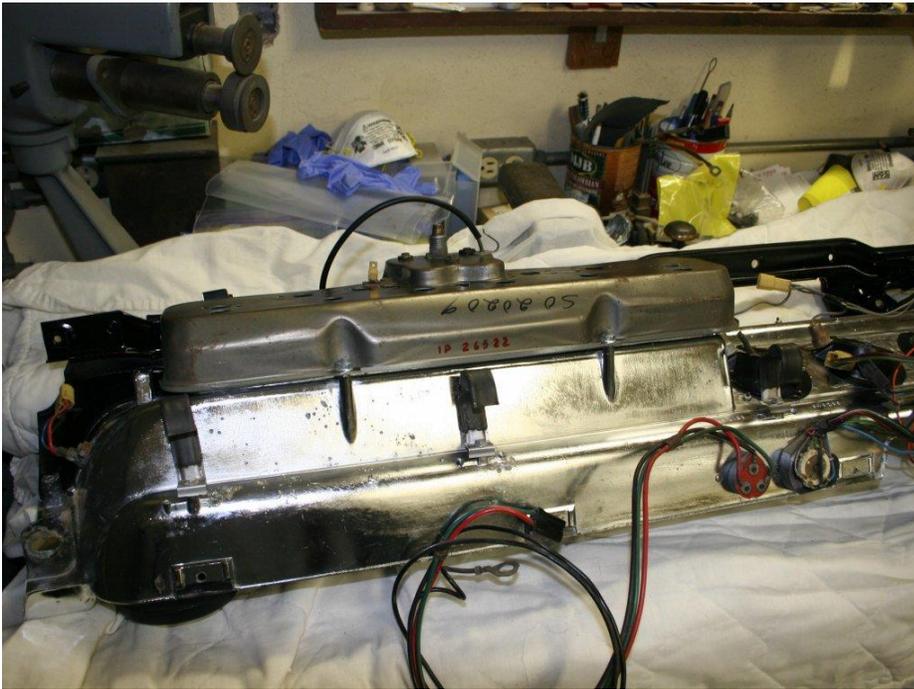
Speedometer with the SO number written on top

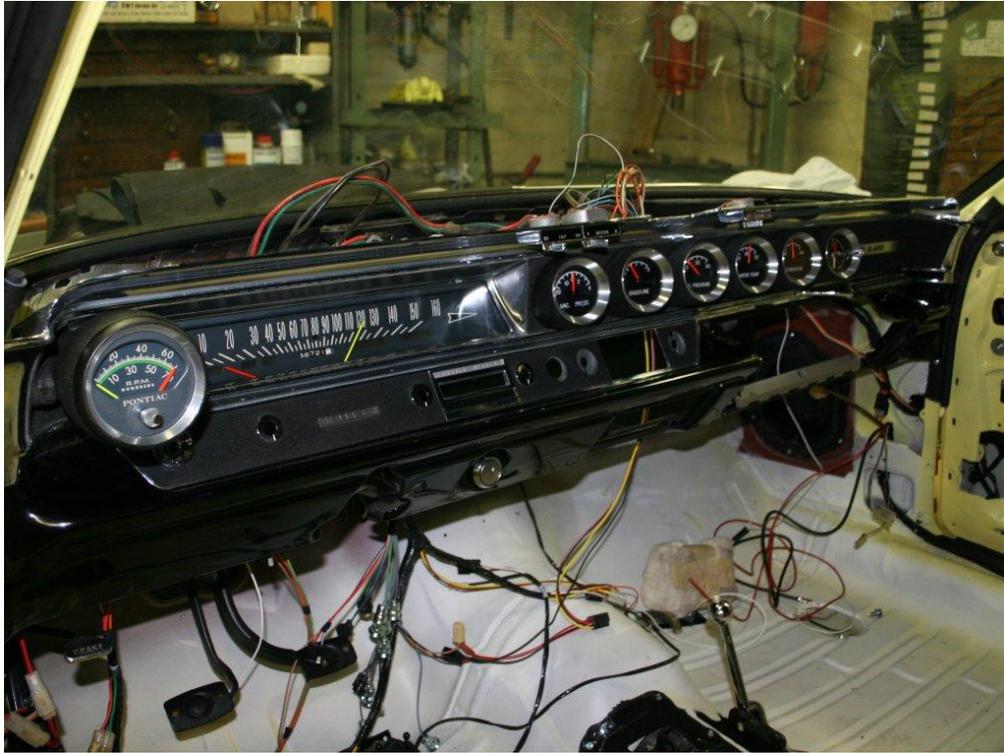
Dash installed
