X400 Log  
2007

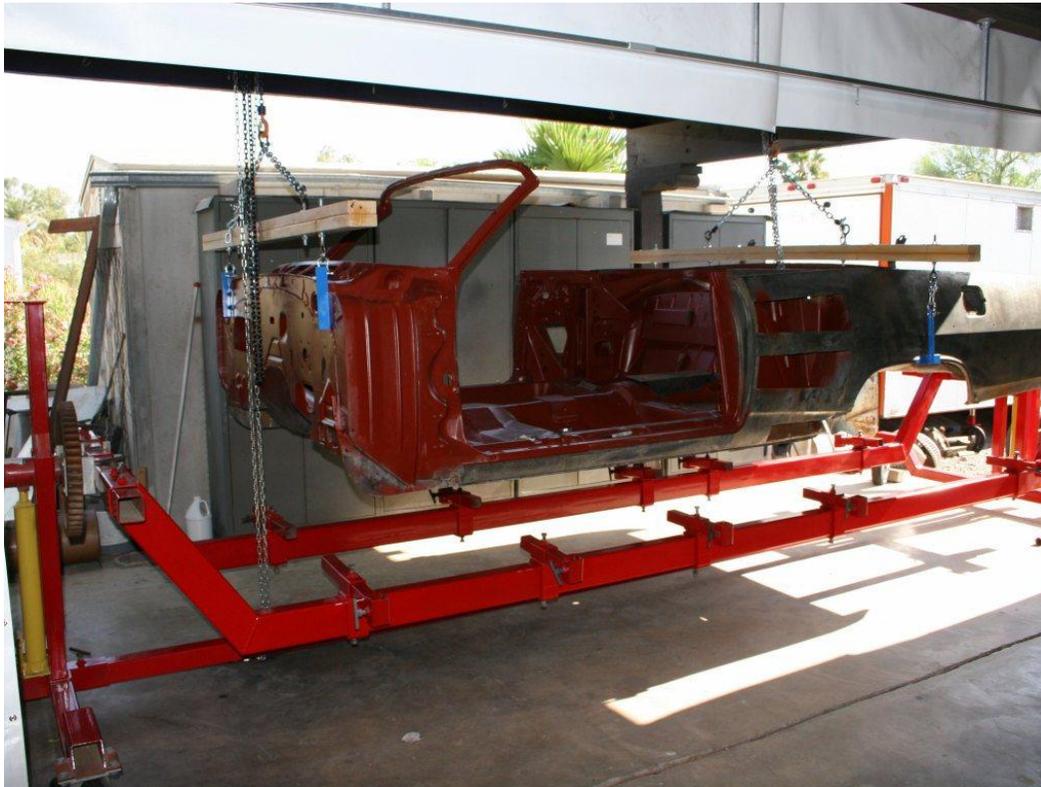
Body going on car cradle

The body was mounted on the rotisserie to begin the body work and repairs. This would involve replacing all the rusted out and damaged parts. I had the body dipped in Phoenix to remove all paint, under coating and rust. First I had to replace several braces under the floor pan. The pans were in good to fair condition and were either repaired with new metal. All of the braces under the floor and body mounts were checked and repaired. When done the bottom of the floor pans was painted satin black as it was originally in the show car and not as it was in production.

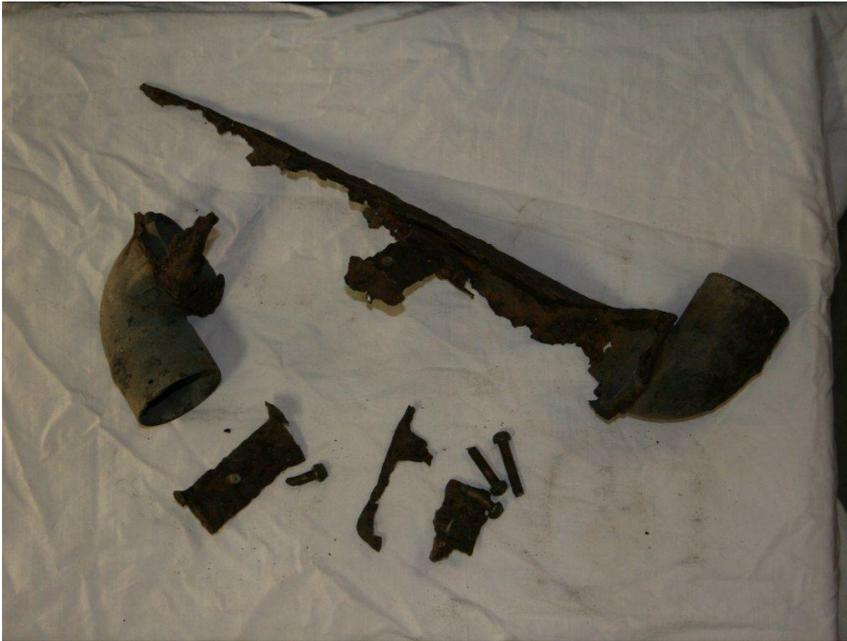
This is what was left of the exhaust port in the body that I had to work with to make the new one.

On the quarters I had to design and make new side exhaust housing for each side. Below is a photo of what was left to show all I had to work from. GM used a 1.25 copper water fitting for these housing. I took the upper indented quarter panel inserts that were on car and designed new one since the ones on the car were nearly rusted away. These were welded in to the quarters and the body work was done. I used body lead for the filler, as it was originally. The body was cleaned and primed with PPG DP74 LF red epoxy primer and then PPG K26 primer. It has had one blocking sanding to remove small defects. The fire wall was coated with wrinkle black, which was used extensively on the car. As of March 2011 the body needs to have the rear trim installed before the final priming and top coating. The trunk lid and doors have were installed and lined up. When I installed the body on the rotisserie, I took a lot of time to level the body on it mounts to the steel frame work. This would be as close as I could come to the position the body would be on the frame. This would let me line things up on the rotisserie. As a note later: this worked very well and the body went on the frame nearly perfectly in 2012

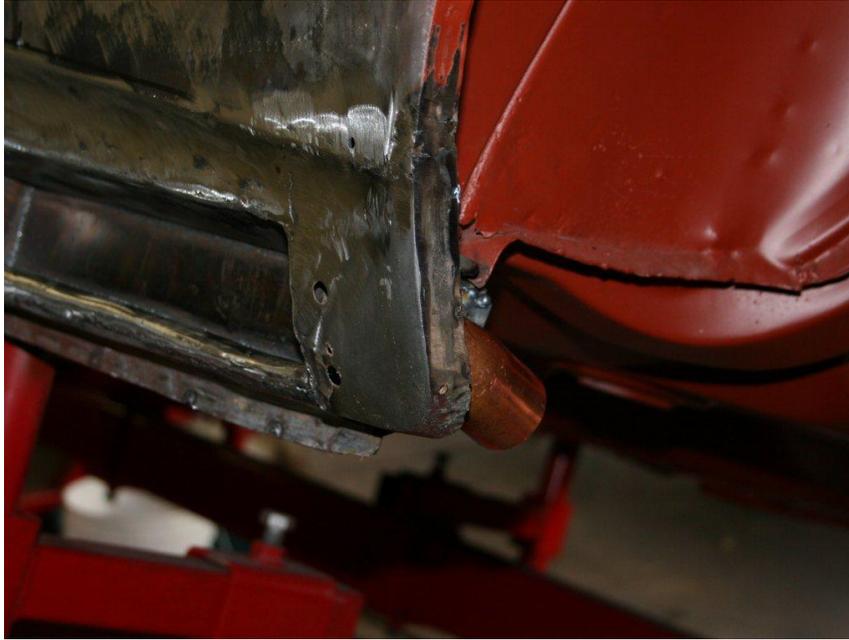
New housing installed

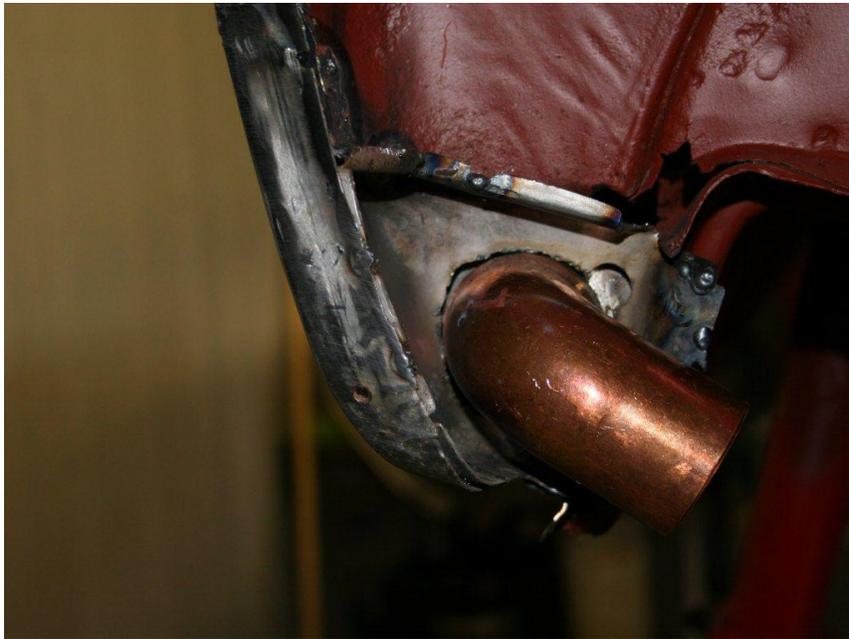
Repairs to body

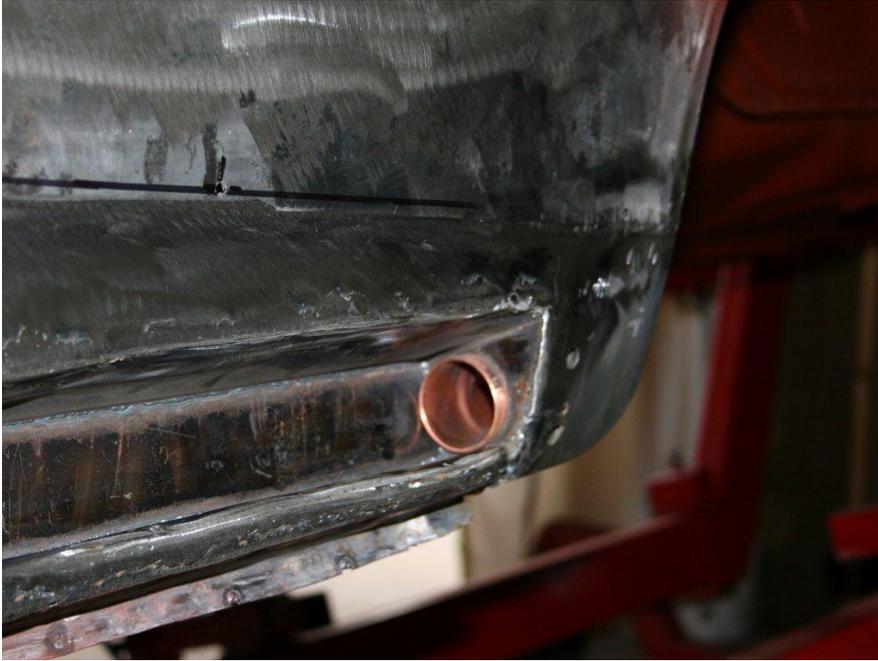
Finish welding
