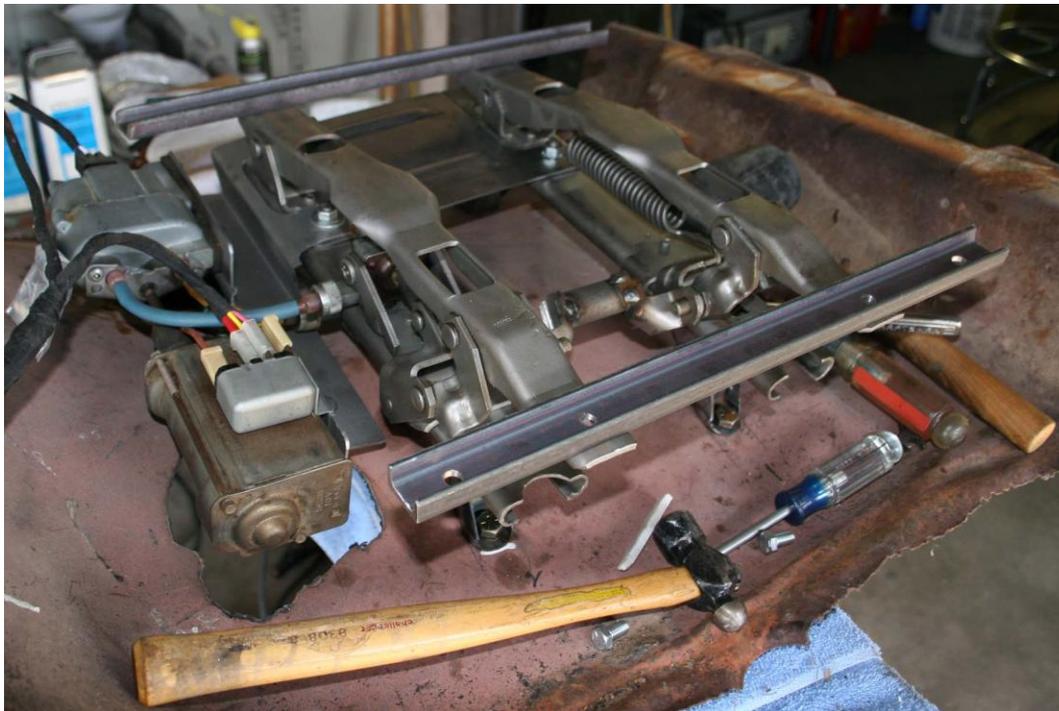
I decided to work with the power seat mounts used for the 1966 buckets and modify them to mount using the hole positions in the floor pans. These would give safe support of the seats and also allow for power tip/tilt as well as forward and back motion.

4 way power seat mount

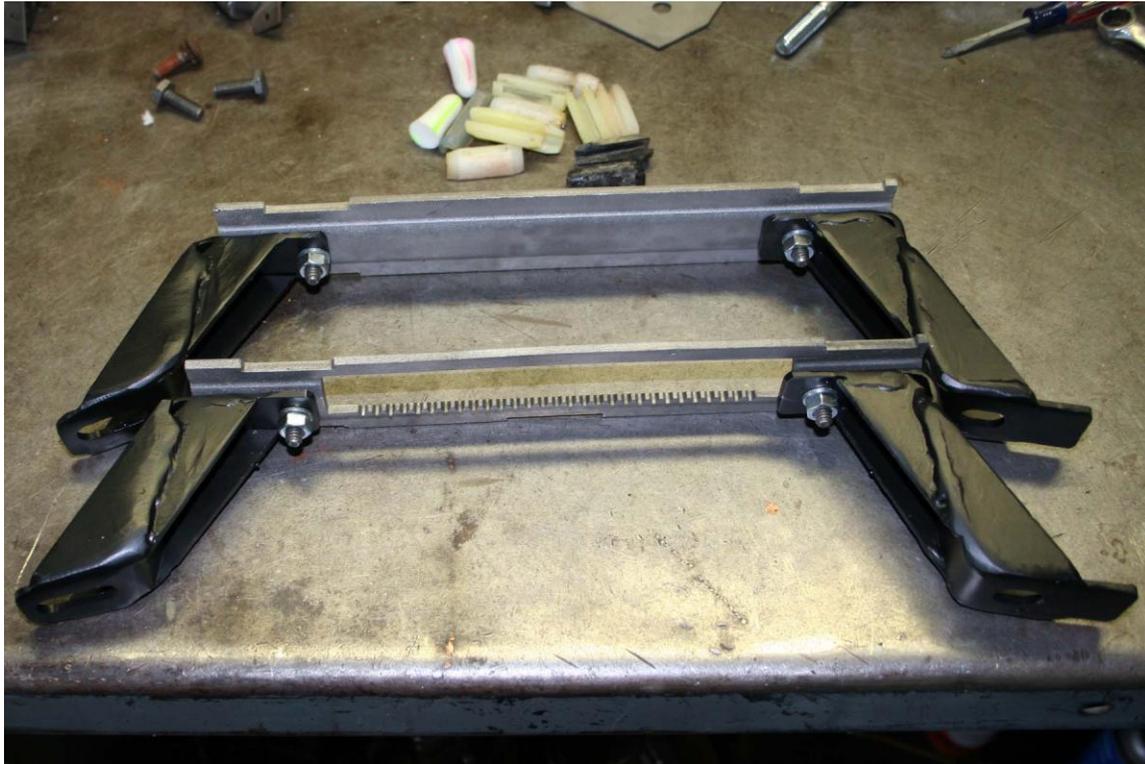
To make the mounts work I had to remove the mounting legs off of the fixed rails and design and make new mounts to fit the holes in the floor.

New seat mount stands

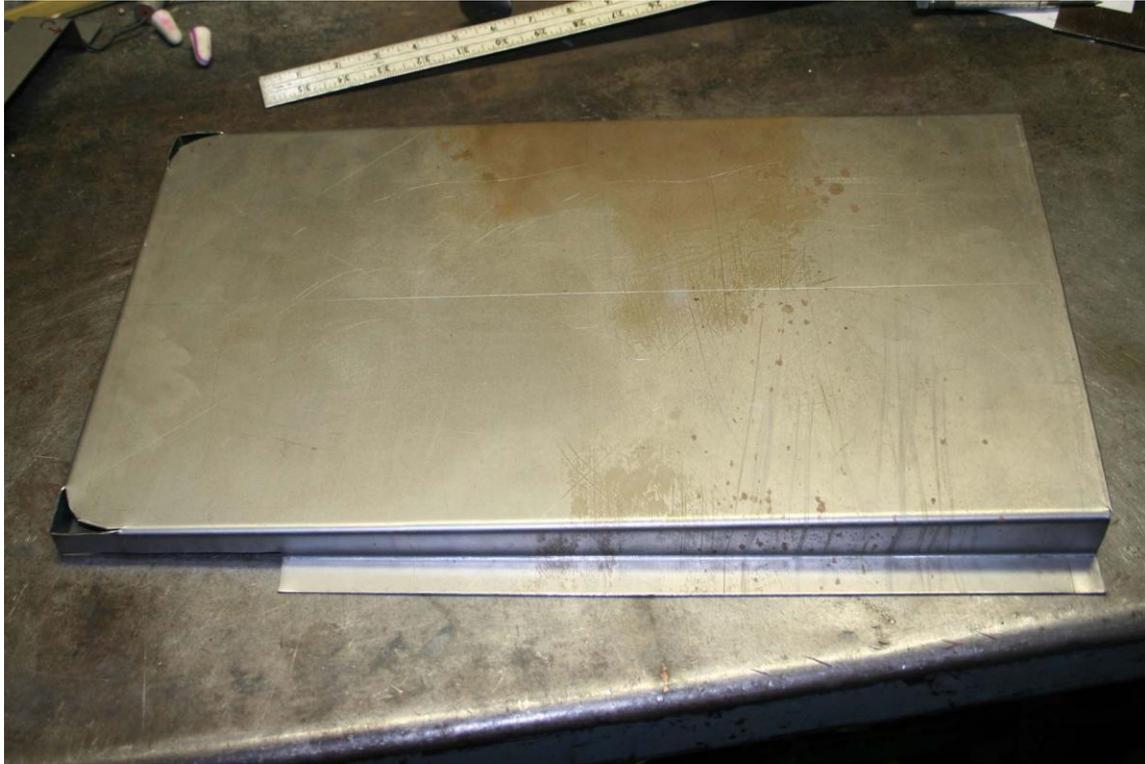
During this time I started on the hood. I had the grills made several years ago. These were based on the grills used on the GTO and from the photos of the of the hood that I got from GM. The hood had to be cut for hood scoops. From the photos, GM removed the central braces under the hood and then attached the scoops. In the literature it was stated that the hood may have been fiberglass, in my research I found it was a standard metal hood cut for the scoops. I used SolidWorks to design the scoops and formed them out of metal.

Hood scoop being formed

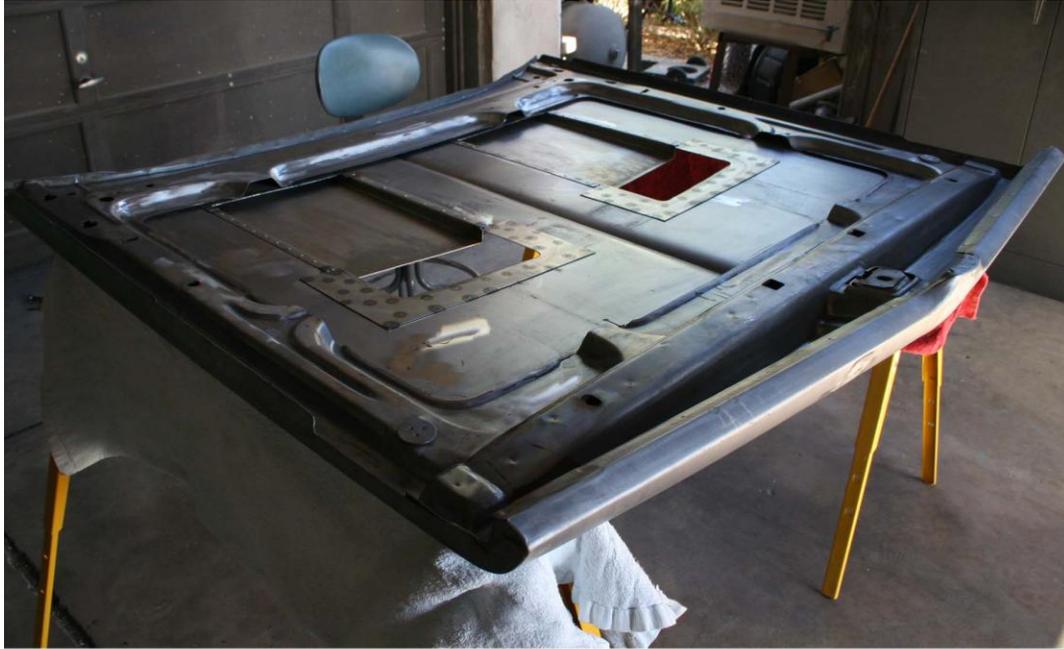
Then the fun began. I took a hood and remove the brace under the hood as it appeared in the photos.

Back side of hood with brace removed

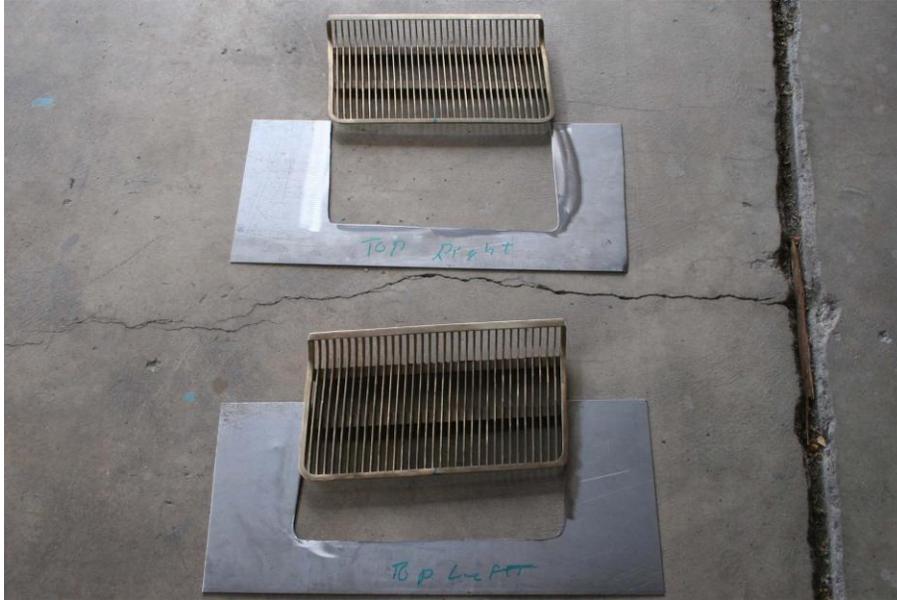
So I had to make new scoops and use a new hood and keep the use of any welding or heat to a minimum. I stripped the hood by hand, cut the hole. I spot welded a metal plate that would hold the grill recessed below the hoods surface.

Metal supports for grills

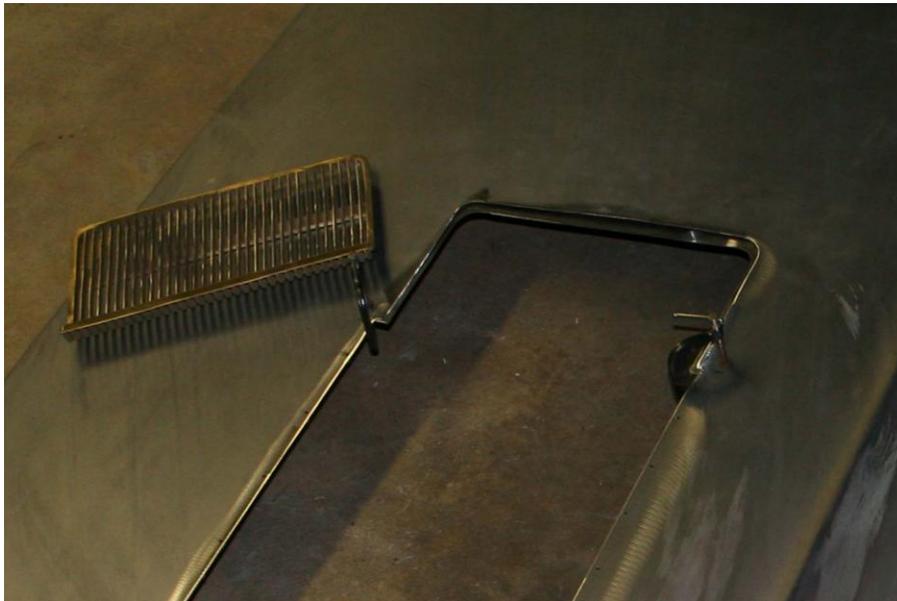
Metal supports being attached to hood

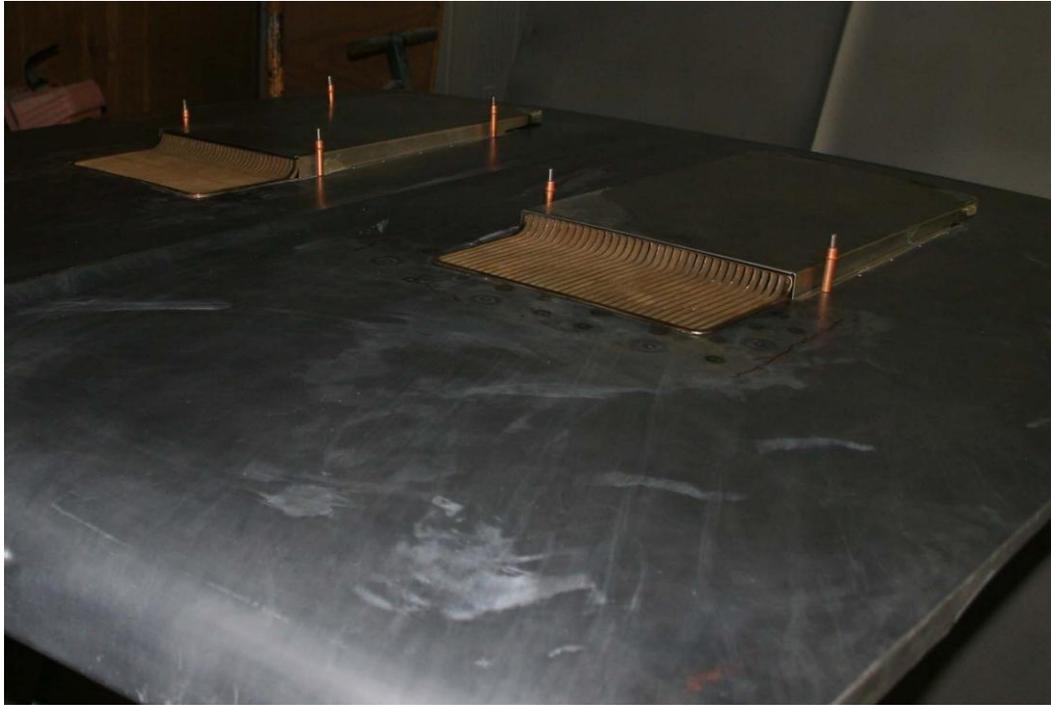
Scoops held in place for tacking in place

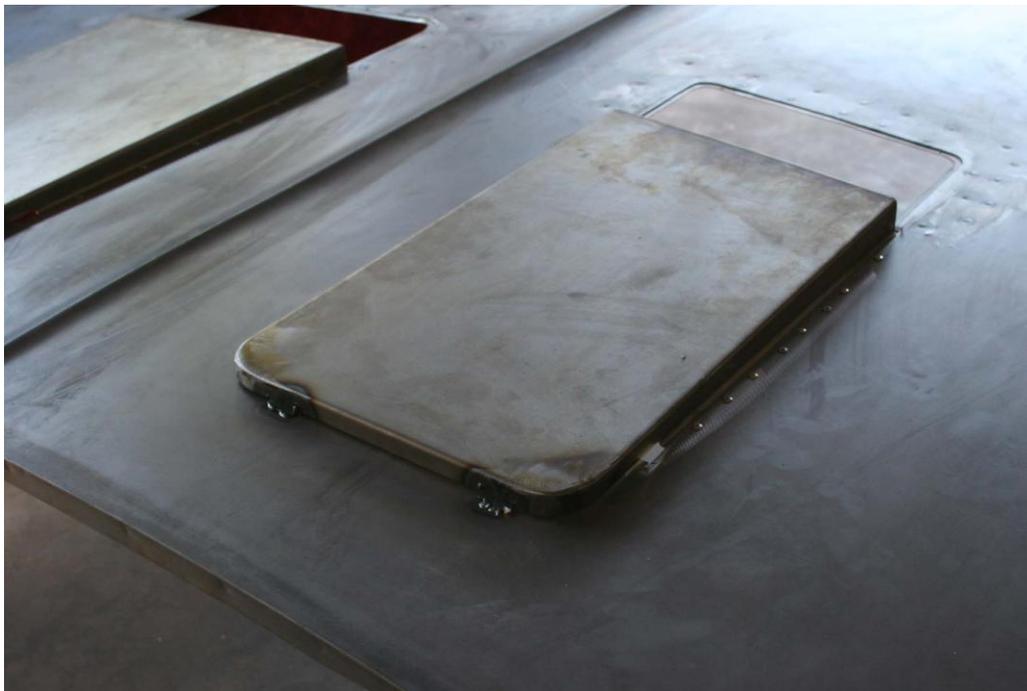
Next I tacked the scoops to hold them in place; Next rivets were used to hold the scoops on so no heat would be used.

Tack welds and rivets installed

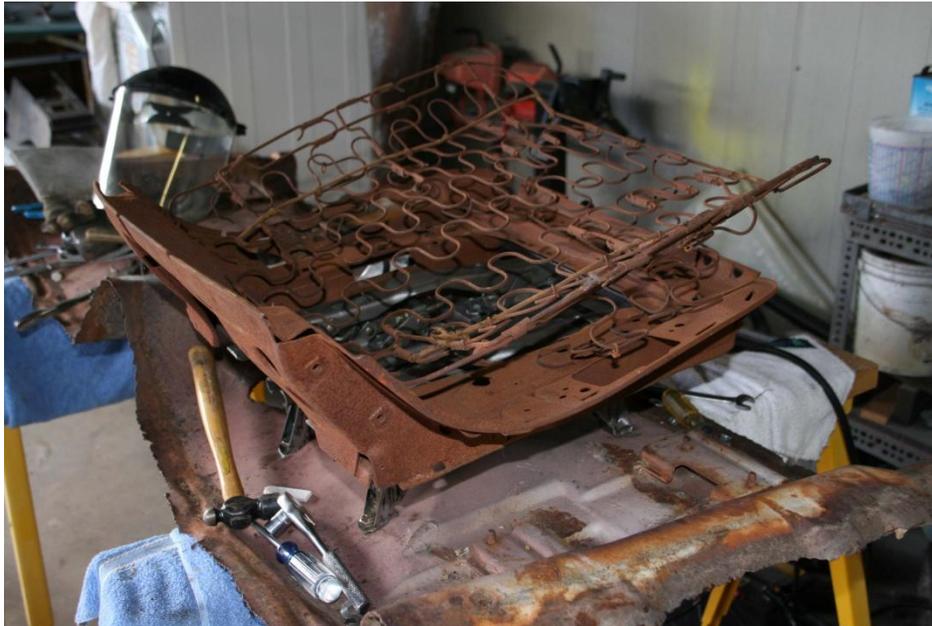
I took each seat frame and stripped off all the old materials and the springs.

Seat before cleaning on new mounts

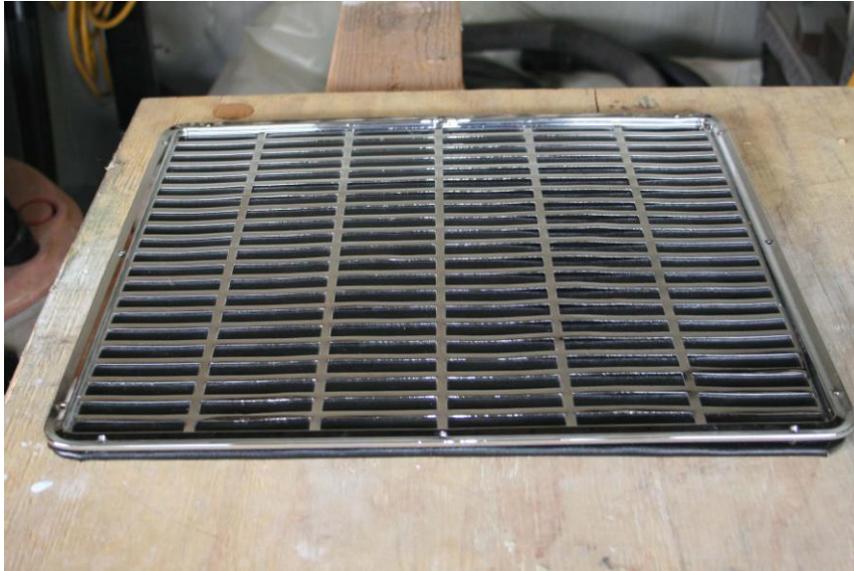
The floor grills were installed. These were the original grills from the car. The outer frame was made of brass and held up fairly well. The grid was made of steel and was rusty. The plating company did a lot of work on these and saved them. GM used vinyl under the grill. I made new pads and screwed the entire grill to a board for months to let the grill imprint the vinyl pad. These were very hard to install since the floor pans are not level surfaces. The frames had been bent to fit the floor pans and locating the screw holes through carpet, pad, sound deadener was a challenge.

Floor grill mounted on wood to impress the vinyl
